CLOCK SPRING®

Caisson Leak Repair

The Clock Spring Leak Stop and Snap Wrap system has been utilised by a major offshore operator in Australia to repair a number of leaking defects on a 36" caisson.

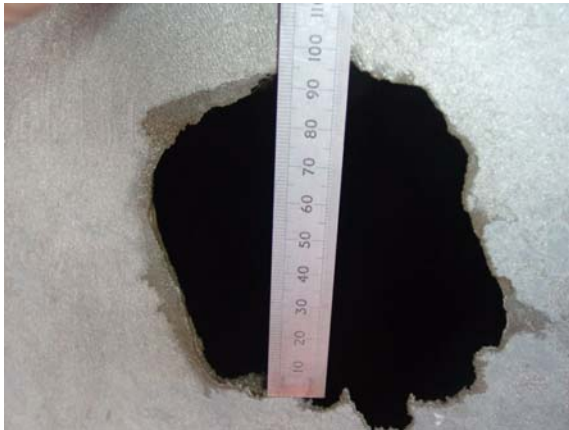
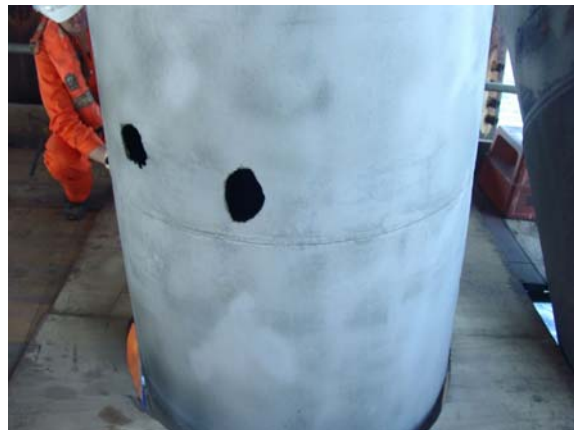
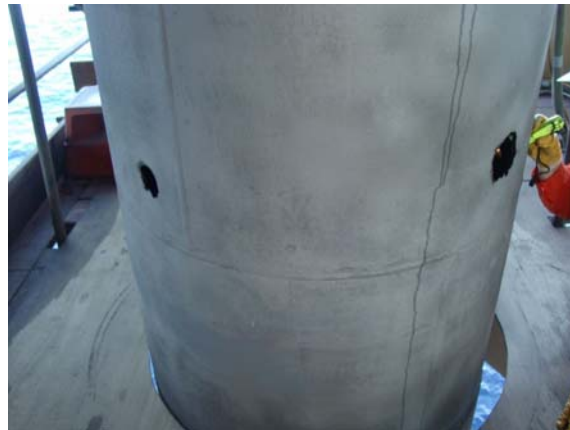
Fig 1

07.30 – 10.00 a.m. blast clean the caisson, NDT inspection, round out and clean away thin steel from the hole and de-burr, perform a secondary blast clean of the repair area (*fig 1*).

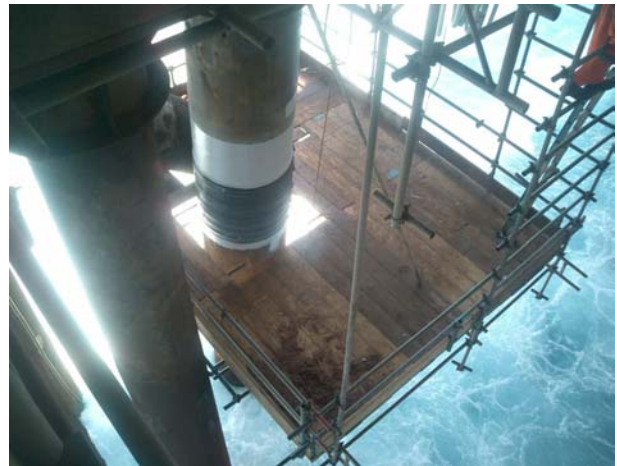
Fig 4

06.00 p.m. caisson returned back into operation (*fig 4*).
