The following report is a pictorial and text account of procedures and operational techniques employed for a Storage Terminal, 42" Suction Line Repair utilising the Clock Spring repair system.

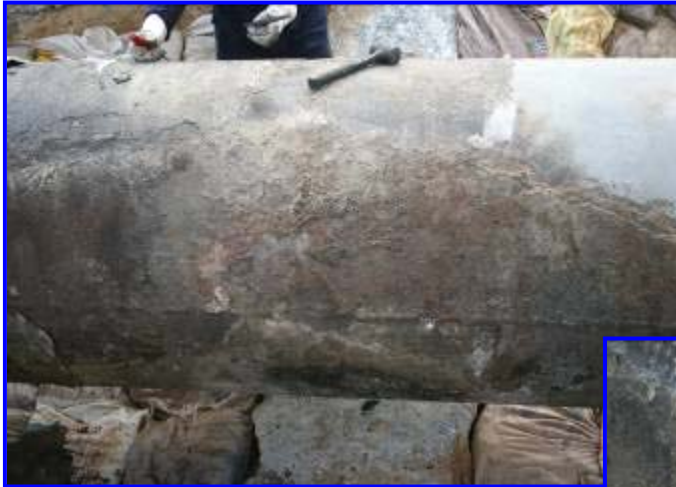
This shows the extent of the corrosion and condition of the "coal tar" coating on the pipe immediately after excavation.

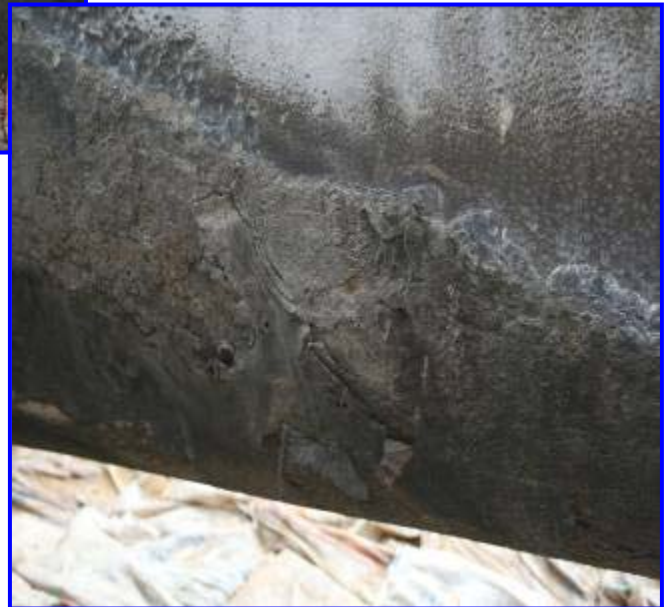
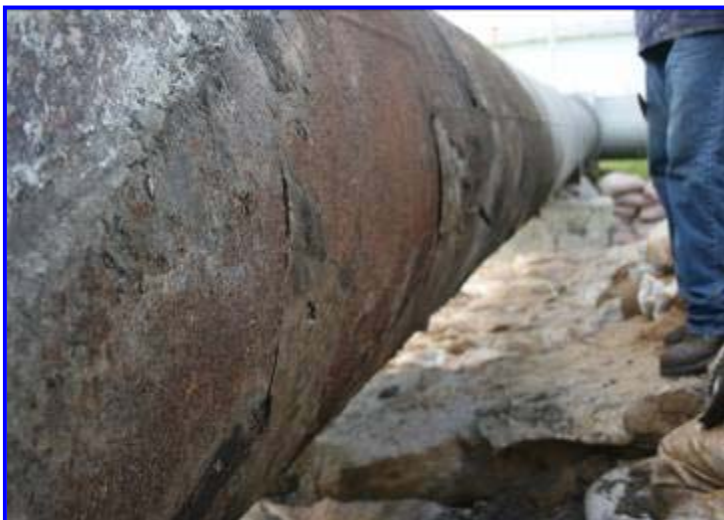
This area is indicative of the underground pipe section, where the coating had failed large areas of severe corrosion were located.

As is evident the corrosion had taken place due to failure of the coating the subsequent moisture ingress, entrapment and the consequential galvanic action.

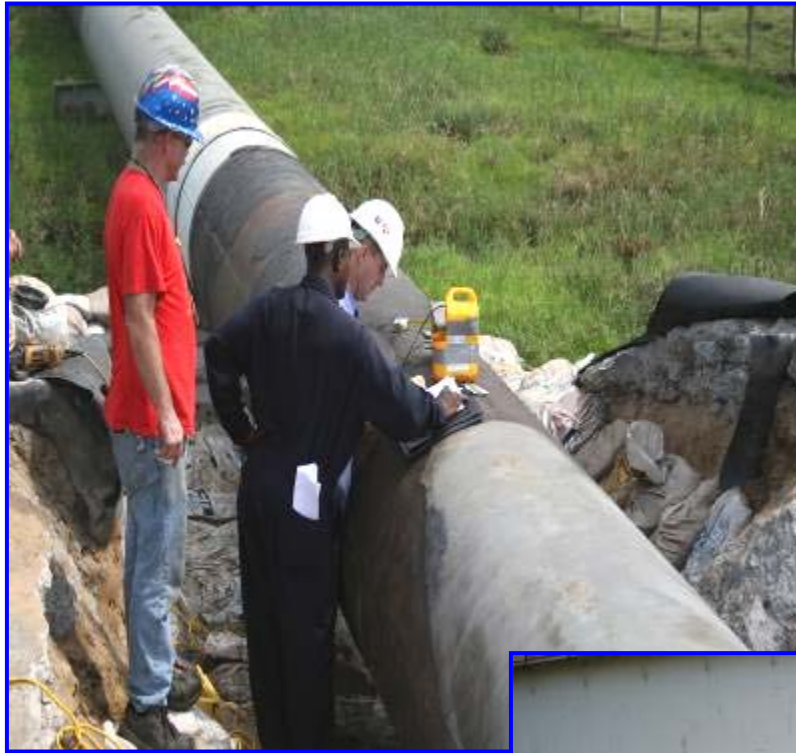
This shows the NDT inspection process taking place.

External corrosion defects of up to 80% metal loss were identified.

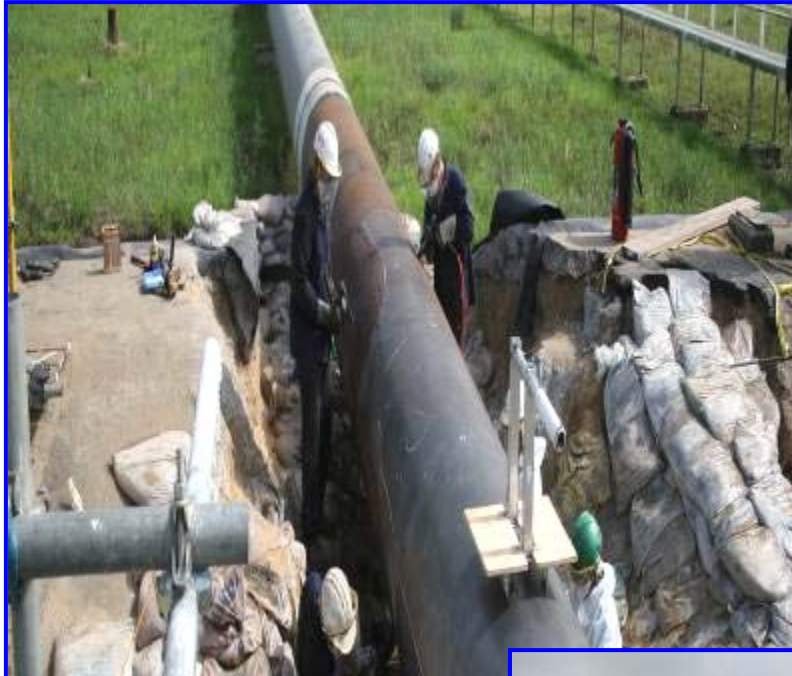
Here 2 pneumatic de-scaling guns are used in tandem with 3 x 7" grinding machines fitted with wire wheels, because of the electrical supply only three machines could operate at one time.

The surface was partially prepared to a NACE 3 standard.

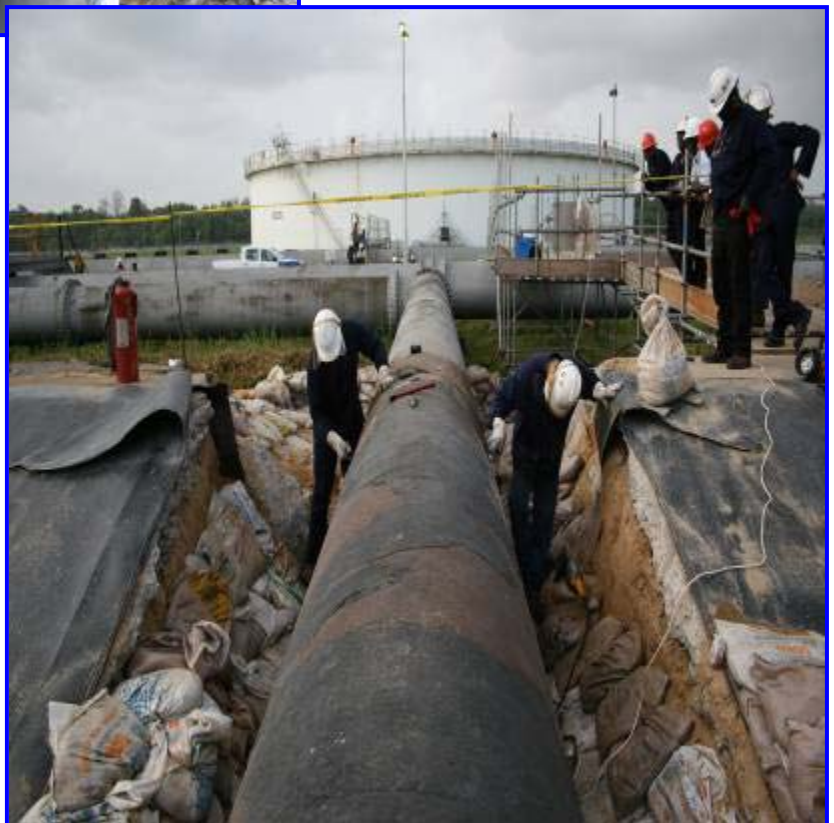
The cleaning of the pipe exposed the extent of the pitting and corrosion.

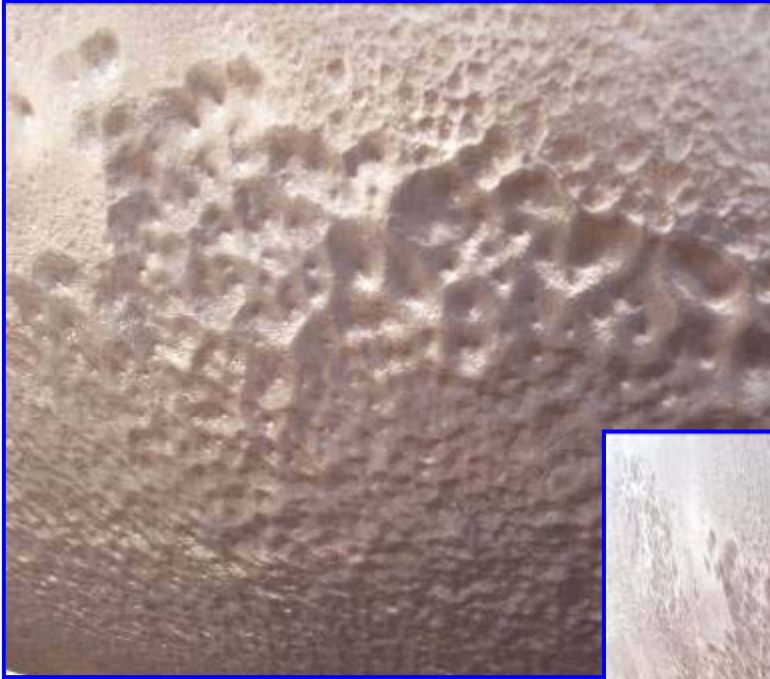
As can clearly be seen the pitting and general corrosion is extensive, all areas were cleaned at first by hand tools then by pneumatic de-scaling guns and finally grinding machines fitted with wire wheels.

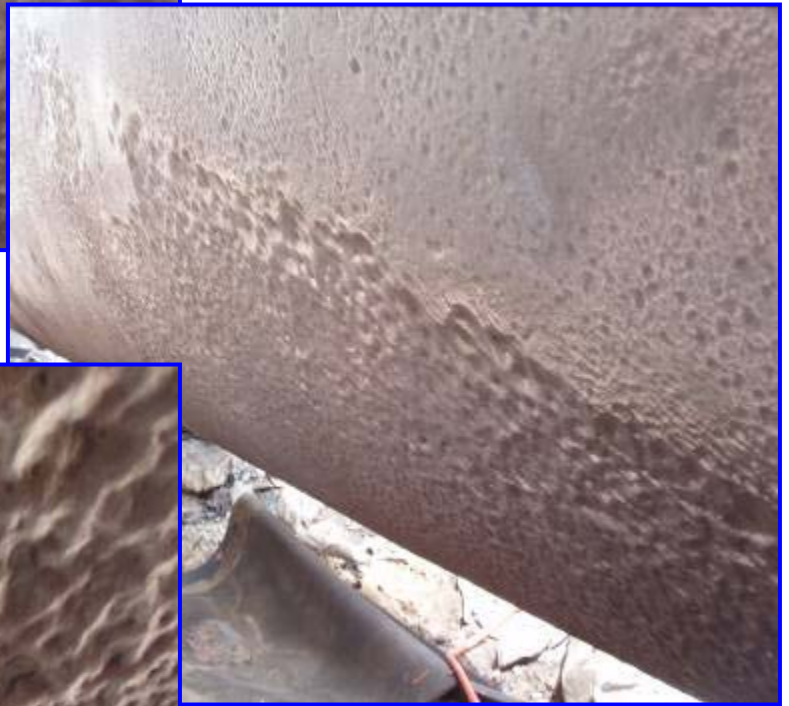
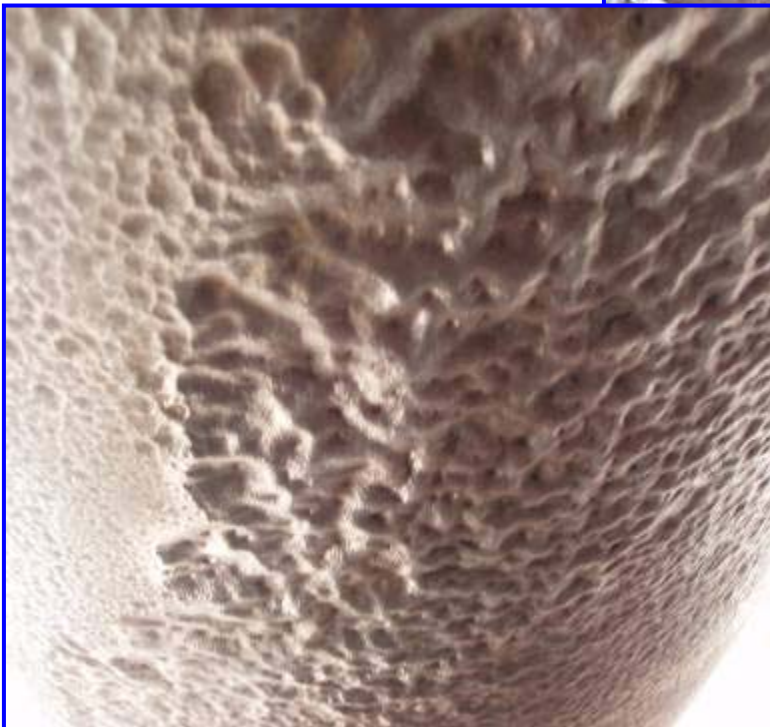
More examples of the extent of corrosion and deep pitting, the vast majority of the severely corroded pipe had previously been buried in the concrete bund wall.

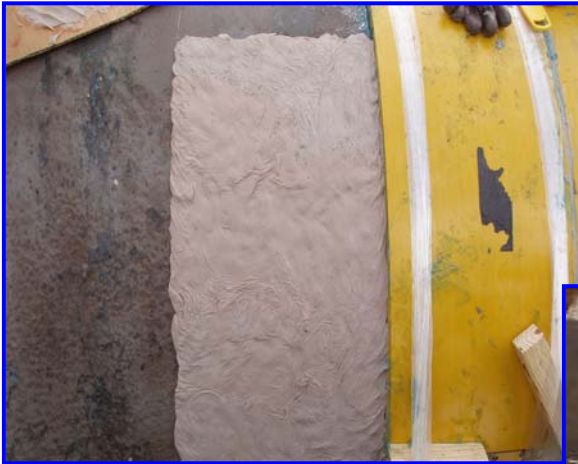
Due to the severe extent of the corrosion it was necessary to mold the Clock Spring filler to bring the surface of the pipe back to its original outer diameter.

**Stage 1:** Apply filler compound around the pipe in an even and uniform layer.

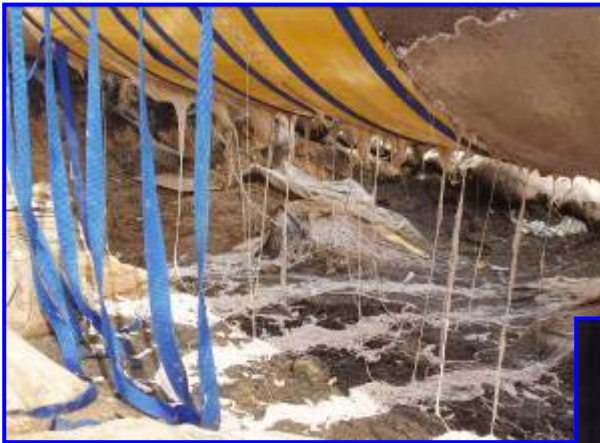
This shows the filler extruded from the sides of the mold.

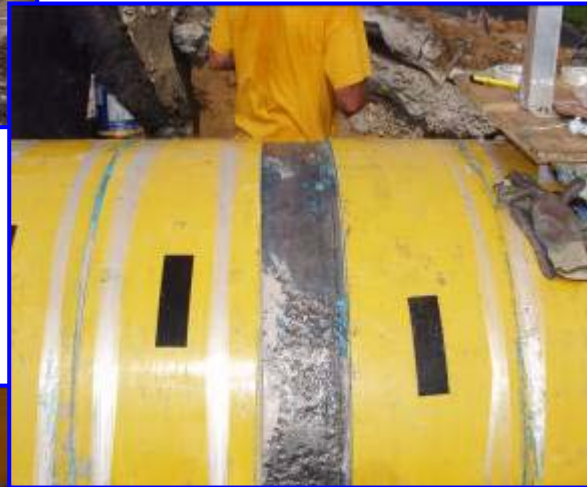
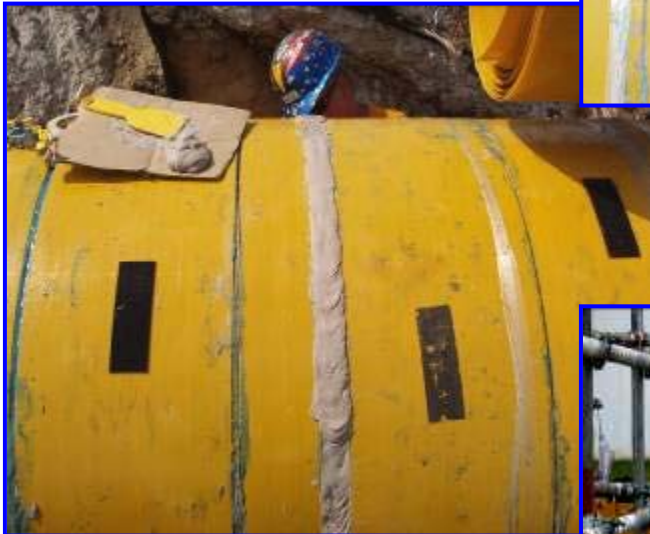
This shows a girth weld being bridged, two Clock Springs are installed either side of the weld and the gap between them then filled with the filler. After this a Clock Spring wrap will "bridge" over the joint.

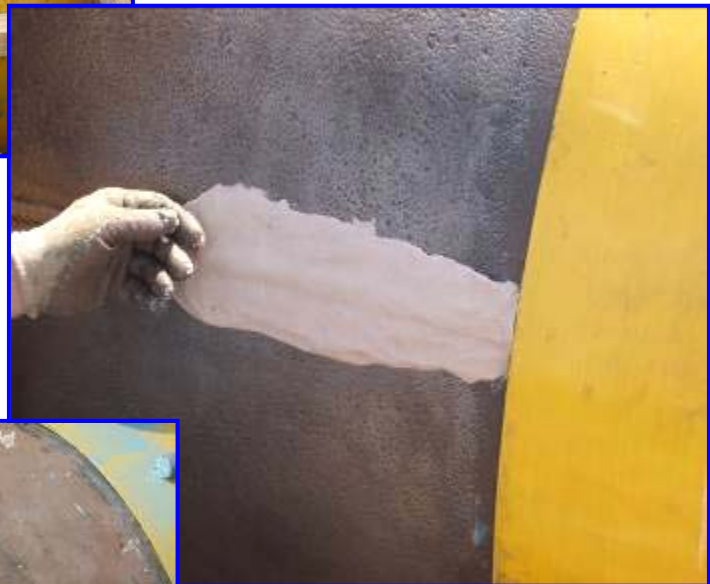
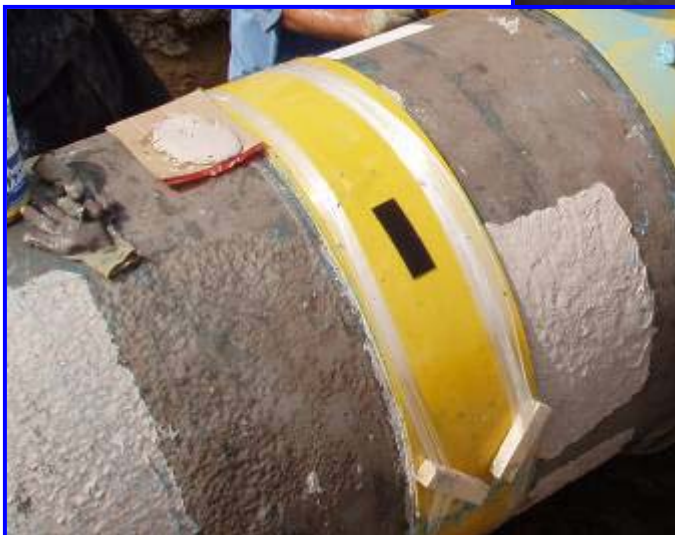
Due to the severe circumferential extent of the corrosion in some areas it was necessary to apply filler to almost three quarters of the overall pipe circumference.

These photographs show the application of more areas of filler both for the corrosion and around the pipes longitudinal weld seam.
