CLOCK SPRING®

Composite Repairs of External Corrosion on 6" and 8" Import Jetty Lines - UK

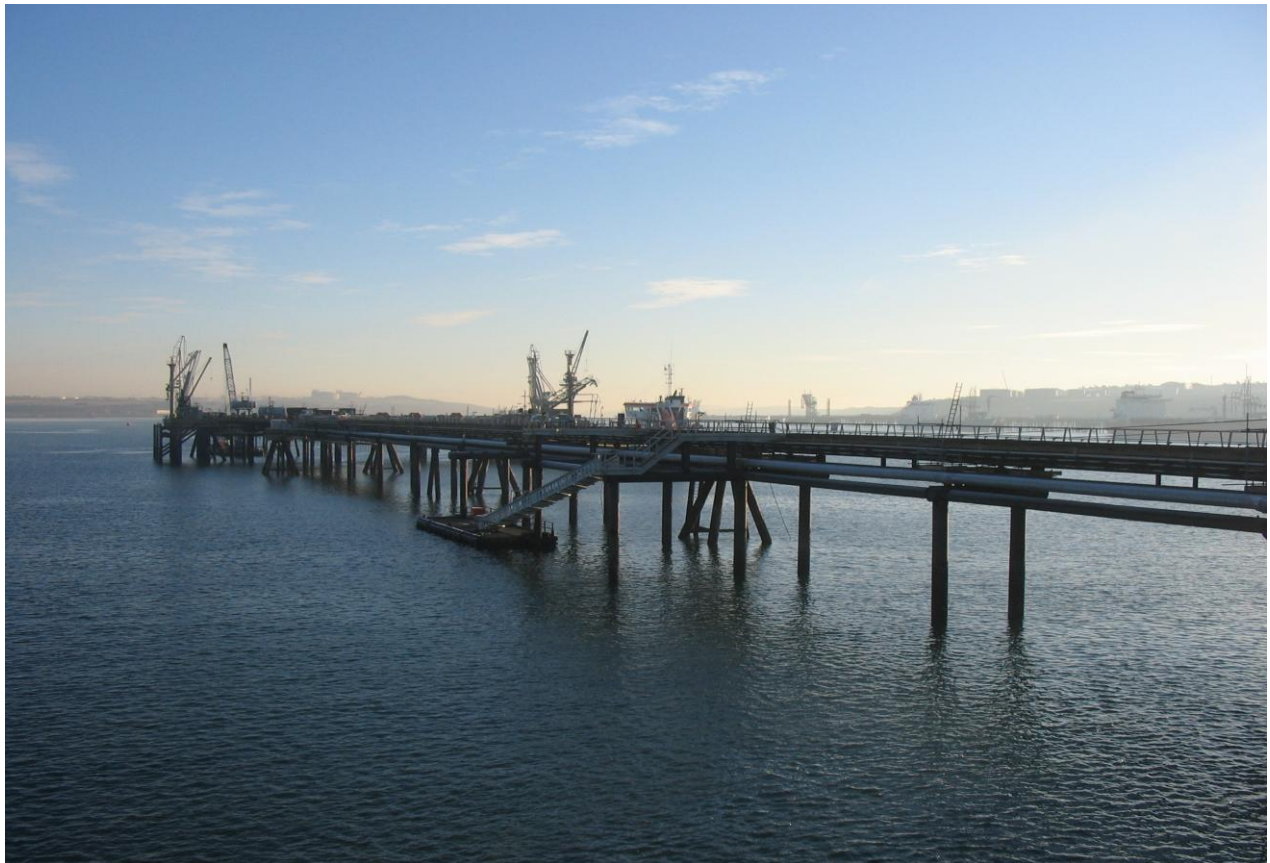
Fig 1

During a routine inspection of 6" Butane and 8" Propane Jetty Lines external corrosion was found, with pit depths of up to 5.5mm, equating to 70% wall loss. This significant wall loss is deemed to be in need of repair to restore the lines to pristine condition.

The pipelines are located beneath the jetty roadway and the corrosion is as a result of continuous dripping of rainwater from the access roadway above.
