## French 12” ‘T’ Repair

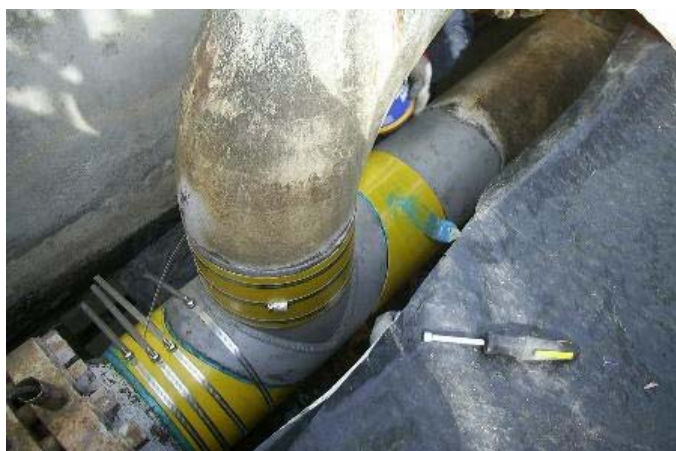
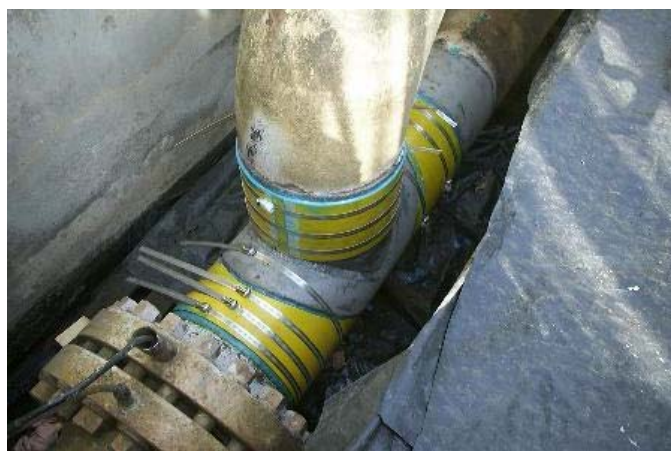
Problem was internal corrosion extending the full length of the underside of the ‘T’ piece. The pressure was 4 Bar Max and the position of the ‘T’ was such that the line was in continuous service. Each Snap Wrap layer was cut individually to fit around the collar and cover as much of the underside of the pipe as possible. Metalplastic was used instead of the MA441 filler material in the event of a possible breakthrough in the future – this would then act as an effective leak repair should that occur.

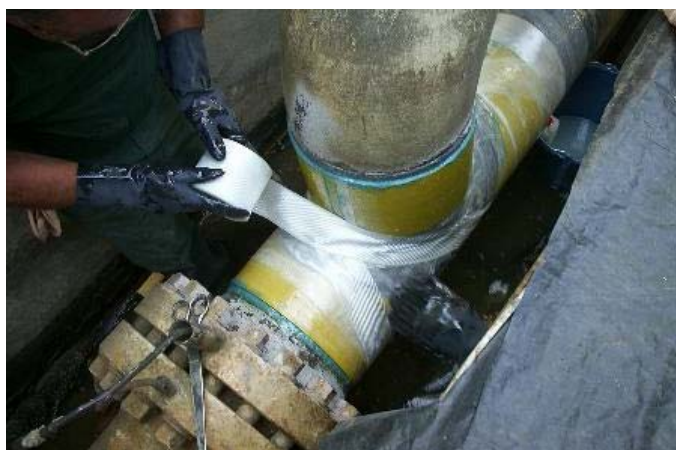
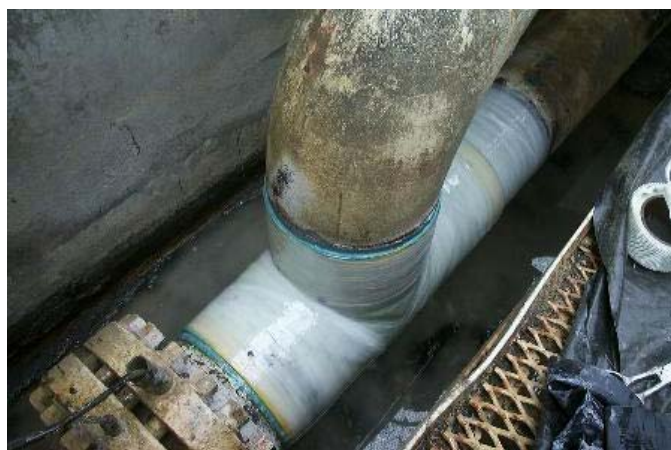
The repair is still considered temporary as it will eventually fail once the pipe deteriorates from the inside to a certain level. However, as the corrosion was measured at depths of no more than 60% and the pipeline was over 30 years old the repair will certainly outlast the remaining expected lifetime.

Once cured, the retaining bands were removed and fibre-glass tape and resin was applied to encapsulate the entire section. The result being a reinforced ‘complex’ section that will continue to operate even after breakthrough from the inside.
