Contour Repairs Nozzle on Thermal Oxidizer

PIPE DETAIL

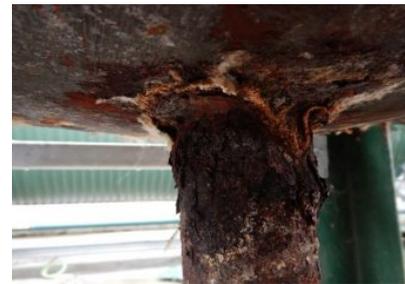
Inspections at an onshore processing plant that receives gas from an offshore facility revealed a severely corroded nozzle on a thermal oxidizer knockout pot. The corrosion covered 60 mm (2.36 in) from the connection to the lower head on a 50 NB schedule 80 nozzle, thinning the nozzle wall to approximately 1 mm (0.04 in) at its weakest point. The extent of the corrosion varied over this length, but the pipe was in sound enough condition to be repaired.

Severe corrosion on the nozzle of a thermal oxidizer knockout pot covered 60 mm (2.36 inches) from the connection to the lower head.
