Contour Repairs Pitting on a Jetty

PIPE DETAIL

457-mm (18-inch) line transporting gas oil

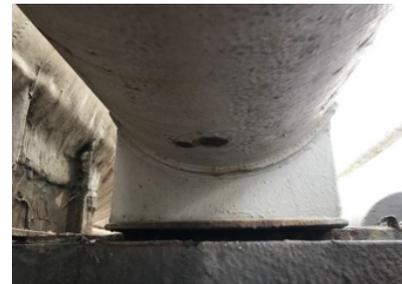
During a planned routine inspection of a 457-mm (18-in) gas oil line on a jetty at a UK terminal, the company discovered a 6-mm (0.24-in) pit that left only 24% wall thickness remaining. An engineering assessment to the local assessment code confirmed a repair was required for the line to remain fit for service.

A planned inspection of a 457-mm (18-in) gas oil line on a jetty at a UK terminal uncovered a pit on a gas oil line.

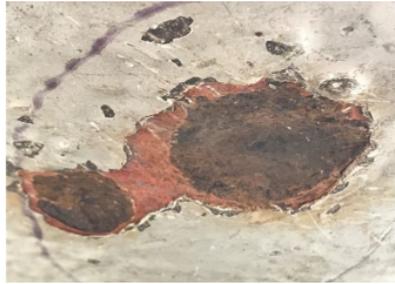
External corrosion 6 mm (0.24 in) deep, leaving 24% wall thickness remaining.

The damaged line had developed a 6-mm (0.24-in) pit that left only 24% wall thickness remaining.

The repair team, made up of local technicians who were trained in the UK by Clock Spring Company over an 18-month period, executed the Contour composite installation in an area with restricted access to the line that was carrying gas oil at 40°C (104°F).
