Contour Tackles Complex Geometry on Ammonia Lines

Leaking ammonia line

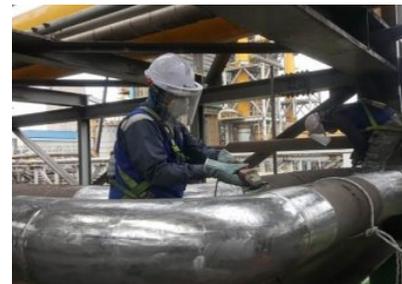
Inspection at a steel mill in Korea revealed that several ammonia lines - 6.5 inch (165.2 mm), 10.5 inch (267.4 mm), and 14 inch (355.6 mm) - under 5 bar (72.5 psi) pressure were cracked in many places. With the hazardous contents leaking in multiple places, including girth welds, in an area of the plant where there were multiple gas lines, the company needed to address the problem as swiftly as possible with a repair solution that would not require hot work.

Installers from Dong-buk E&C prepare the surface of the pipe for the Contour repair.

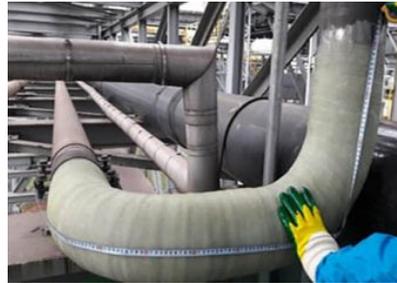
The installation team applies the Contour fiberglass cloth to the pipeline.

A team of 6 Clock Spring trained and certified installers from Dong-buk E&C applied 5 layers of Contour to multiple leaks ranging from 1 mm to 5mm (0.04 - 0.2 inch) in length. Each area was filled with Clock Spring's proprietary filler before being overlaid with fiberglass cloth.

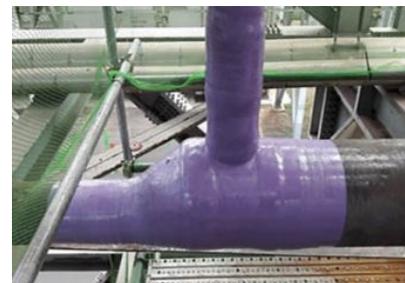
The Clock Spring Contour repair restores the line to safety.

All 147 repairs were completed in 15 days with a solution that was quick to deploy, easy to install and will last for decades.
