Contour Reinforces Corroded Cooling Water Line

PIPE DETAIL

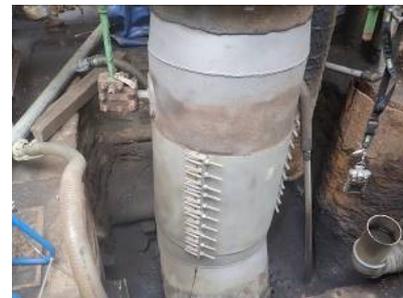
Internal corrosion on a DN700 (28-inch) cooling water line in a refinery in Western Europe led to a loss of containment that required attention. The leak was stopped using a pipe saver, and a second leak on a DN 25 (1-inch) elbow from a nozzle off the DN700 pipe was addressed with a traditional leak box. The operator wanted the clamps to be wrapped with Clock Spring Contour to ensure the pipe would remain fit for purpose until the next planned shutdown for the cooling water system.

The leaks initially were contained using temporary clamps.

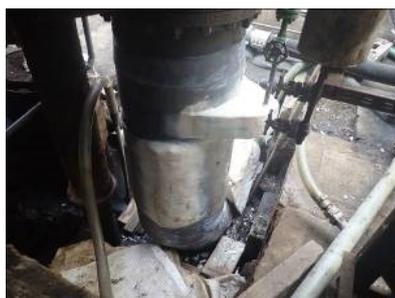
Clock Spring-trained installers from Interseal

A composite solution was ideal for this pipeline because the remaining wall thickness was insufficient for a welded repair. The thin pipe wall posed a welding risk because of the danger of accidental burn through and creating a larger leak.

used filler to reshape the leaking pipe in preparation for the Contour repair.

After careful deliberation, the decision was made to repair the lines using Contour, an engineered wet applied repair system, featuring quad-axial stitched fiberglass cloth applied in a wet-lay system with two-part epoxy and a filler material.

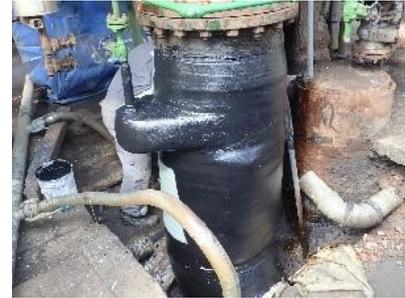
The completed repair gets a coat of paint.

Clock Spring trained installers from [Interseal](#), an authorized distributor in Antwerp, Belgium, inspected the pipe surface and grit blasted the areas deemed sound enough for repair. A team of 2 technicians applied filler material around the clamps to ensure there were no voids under the repair, creating a shape that would be easier to wrap. With the pipe prepared, the technicians applied 9 layers of Clock Spring Contour to the straight pipe and 14 layers at the T. When the composite was completely cured 8 hours later, the installers painted over the repaired area.
