## Composite Solution Seals Crack in Gas Transmission Line

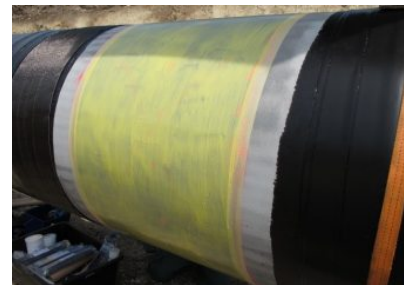
A gas transmission line operator discovered a 25-mm (0.98-inch) longitudinal crack on a bend section of a 900-mm (35.4-inch) diameter carbon steel pipeline that was under considerable loading. The crack had penetrated 80% of the wall thickness and posed a significant safety threat.

The prepared section of pipe is ready for the fiber wrap.

Following normal installation procedures, the team uncovered the pipe and sandblasted the surface to prepare it for the repair. After applying filler and primer, the technicians applied the carbon fiber material to the damaged line.

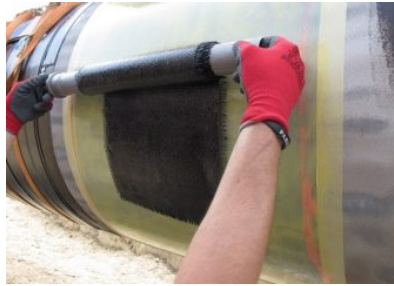
A Clock Spring trained and certified repair technician from SEPS applies DiamondWrap® to the damaged pipe.

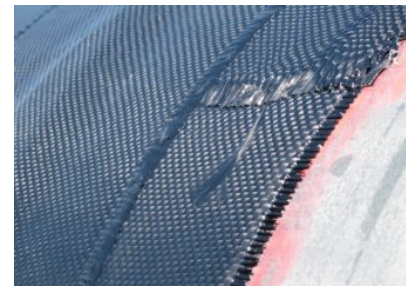
Each successive layer of DiamondWrap® increases the pressure rating. The bidirectional weave allows for strength in both the hoop and axial directions and ensures that there is no reduction in strength over time.
