## Offshore HP Separator Leak Stopped with Contour

152.4-mm (6-inch) outlets on the main high-pressure (HP) oil/gas separator had multiple severe internal erosion defects.

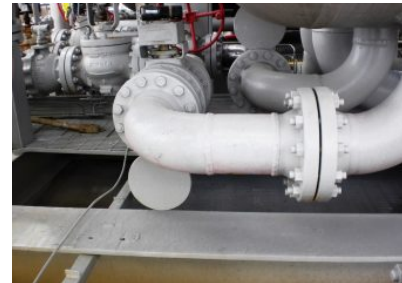
The erosion was growing at such a rate that imminent failure was likely. It was imperative that repairs be made immediately to avoid shutting down the platform, resulting in huge loss of production.

UT inspection revealed severe internal defects on the 152.4-mm (6-inch) outlet of the main HP oil/gas separator on an offshore platform.
