Contour Repairs 4-inch Prover Loop

A 4-inch (101.6-mm) Prover Loop line on a metering skid had several pinhole leaks

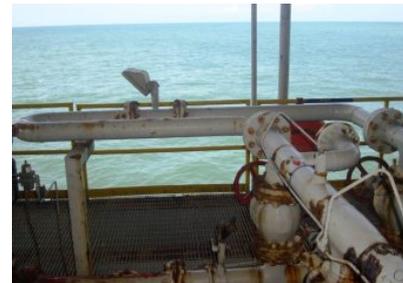
External corrosion resulted in several pinhole leaks on 4-inch (101.6 mm) diameter sections of the prover loop on a metering skid on a platform offshore West Africa. Three clamps had been installed on various spool sections to address the damage, and plans were in place for the skid to be replaced at the next scheduled shutdown; however, the condition of the skid and the potential for environmental impact if further leaks were to occur led to the decision to reinforce the lines so operations could be continued safely until the damaged sections of line could be replaced.

The Prover Loop comprises five spool pieces, where corrosion had created multiple pinhole leaks.

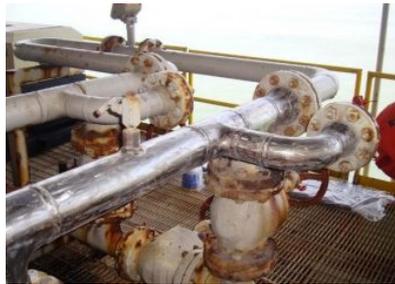
The repair area is cleaned to SSPC.SP11 surface preparation standards.

The next step was to clean the area to the SSPC.SP11 standard, making sure the surface was free of all visible oil, grease, dirt, dust, mill scale. The paint was removed, and the pipe surface was 'keyed' to give sufficient bonding between composite (fiber glass) and substrate (steel pipe).

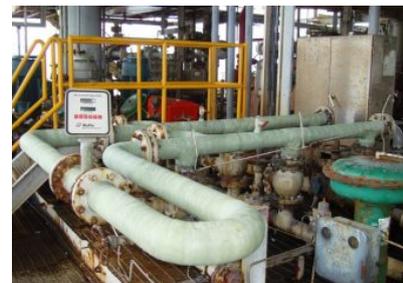
When the composite repair was cured, the peel ply was removed and the repair inspected for de-lamination, dry spots, and disbonding before the line was coated for UV protection and returned to service.

Because of the complexity of the spool geometry and the repair length, the installation team wrapped each spool separately and in stages. In each instance, 4 layers of glass were applied. With the glass wet, technicians applied a holding layer of peel ply over the repair to protect the glass from contaminants while the resin hardened and allowing excess resin to soak through.

When the composite was fully cured, the peel ply was removed and the repair inspected for de-lamination, dry spots, and disbonding. With all of the pinholes addressed, the prover loop was coated for UV protection and returned to service in only 4 days.
