Contour Mends Pinhole Leak on a Topside Weldolet

10-inch (254-mm) pinhole leak at a weldolet on an oil line

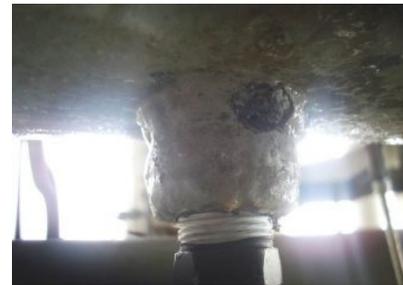
It was important to repair the weldolet because of its role in minimizing stress concentrations and providing integral reinforcement to the line. Inspection revealed leaking oil in the weld area at the chemical injection point.

The hole is sealed using a small amount of hand mixed epoxy so LEL levels could be established at 0%.

A team of 2 Clock Spring trained and certified installers sealed the pinhole using a small amount of hand mixed epoxy so that LEL (Lower Explosive Limit) levels could be established at 0%. The next step was to clean the area to be repaired to the SSPC.SP11 standard, using power tools on the bare metal, leaving the surface free of all visible oil, grease, dirt, dust, mill scale.

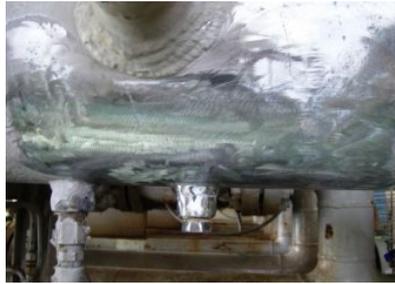
Repair area cleaned to SSPC.SP11 surface preparation standards.

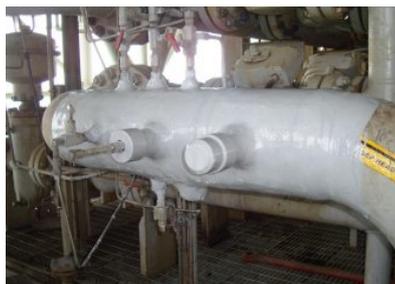
The repair section is coated for UV protection.

Since the line was completely shut down, the owner decided to extend the repair on each side of the weldolet. The line sections were cleaned to SSPC.SP11, and four layers of glass were applied on each side of the initial repair. As in the earlier repair, the peel ply was removed when the resin had cured, and the glass was inspected for defects. When the determination was made that the repair was sound, the entire area was coated for UV protection.

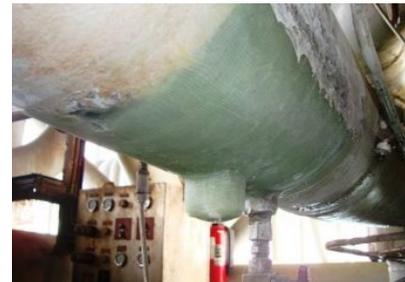
With the resin cured and the repair inspected for defects, the peel ply is removed.

Peel ply was applied over the entire repair during the curing process. When the resin cured, the peel ply was removed, and the repair area was inspected for defects such as de-lamination and dry spots.
