Black Diamond Restores 36-inch Gas Pipeline

PIPE DETAIL

36-inch (914.4-mm) gas line

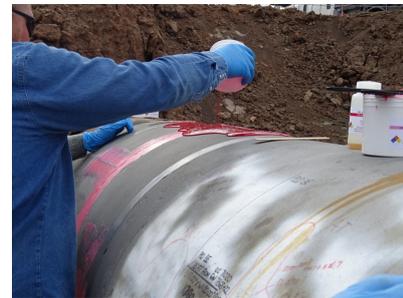
Primer is mixed and poured over the prepared pipeline.

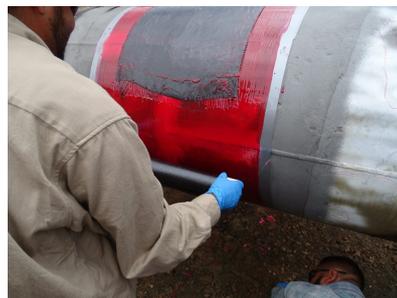
A trained technician uses a 2-inch (50.8-mm) OD tube to help keep tension the carbon-fiber fabric while installing it on the pipe.

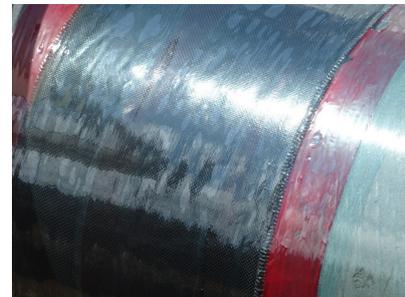
The repaired line is cured and ready for continued service.

The repair was completed in approximately 2.5 hours and was fully cured in 8 hours. This approach returned the line to safety, delivering a quick, reliable repair that did not require the line to be taken out of service.
