Composite Restores Wind Tower Flare Line Integrity

PIPE DETAIL

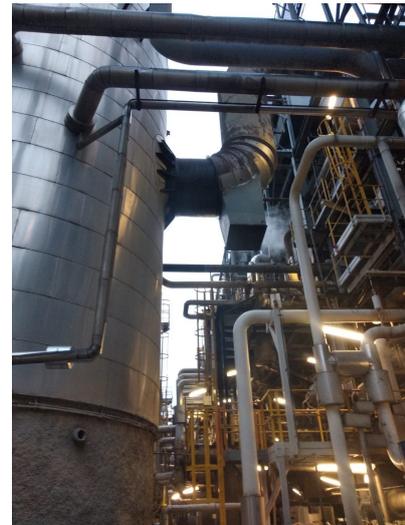
The elevation of the line made it difficult to access the damaged pipe, which complicated the repair.

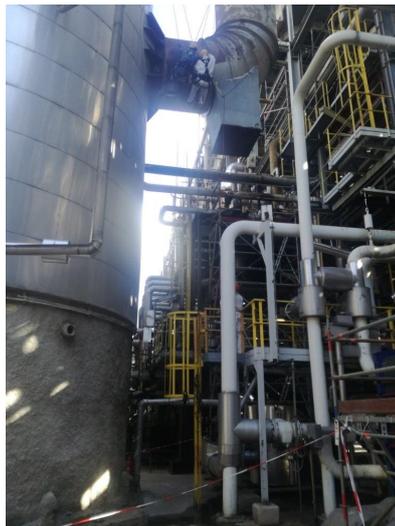
Workers use rope access to inspect the pipe.

Using ropes to access the flare line, Clock Spring experts assessed the damage and suggested carbon fiber DiamondWrap® with HTA (High Temperature Ambient) epoxy for the repair. The DiamondWrap® system includes a bidirectional weave of carbon fiber and a 100% solids epoxy that form a composite system stronger than steel. Its low profile enables installation in confined spaces and on irregular surfaces.
