EZ Valve™ Restores Ruptured Water Main to Safe Service

16-inch (406.4 mm) cast iron water main

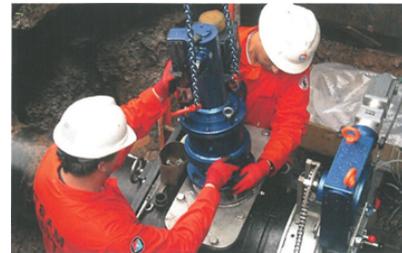
Alterations to the EZ Valve™ allowed installation on the irregular dimensions of the old cast iron main.

The compact valve profile allowed for a smaller excavation than other valve systems, and because costly restraint operations were not required, only one excavation was needed. Unfortunately, the installation began with a setback. The irregular dimensions of the old cast iron main required alterations to the valve fittings on the EZ Valve™ so it would work properly on the cast iron main. Meanwhile, weather conditions had deteriorated, with gusting wind and temperatures well below freezing.

Despite these challenges, the team was able to install a 16-inch (406.4 mm) insertion valve. The extra on-site work added about 1.5 hours to the process, but the valve installation that followed took only 4 hours. With the valve in place, municipal workers could begin making repairs.
