Leak Stopper, DiamondWrap® Restore Leaking Pipe to Safe Service

A 12-inch (305-mm) carbon steel pipe transporting harsh chemicals suffered a pinhole leak caused by internal corrosion

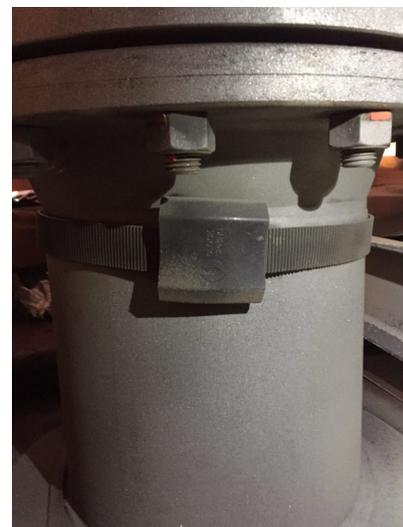
Stopping leaks quickly is vital to maintaining critical infrastructure. When a refinery owner in North America discovered a pinhole leak on a 12-inch (305-mm) carbon steel pipe, there was an immediate move to address the problem. The leak, caused by internal corrosion, was in a weld on a nozzle, and the refinery was at risk of a shutdown. A hose clamp had failed at providing a stopgap fix, so in order to avoid interrupting operations, it was essential to find a better solution.

Installers secured Leak Stopper on the pipe, creating a low-profile repair that was ready to be overwrapped with the DiamondWrap® for a lasting repair. (Photo courtesy of ClockSpring|NRI)

A team of 2 trained and certified installers secured the band of the Leak Stopper on the pipe to cover the leak and used a ratchet to tighten the band until the leak was stopped, stopping the leak within less than a minute. Using the back of the tightening tool to trim the excess slack from the band, the team created a repair with

a finished profile that is only 1 inch (25.4 mm) wide that was ready to be overwrapped with the DiamondWrap® for a lasting repair.

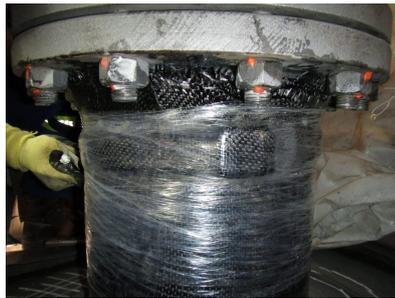
Technicians applied 4 axial strips of carbon fiber over a length of 18 inches (46 cm) to repair the nozzle and achieve the final design, restoring safety within 1 hour without requiring the line to be shut in. (Photo courtesy of ClockSpring|NRI)

With the leak safely arrested, the installers proceeded with the application of four layers of axial strips of carbon fiber over a length of 18 inches (46 cm) to repair the nozzle and achieve the final design, restoring safety within 1 hour without requiring the line to be shut in.
