Composites Extend Service Life of Corroded Flare Line

SUMMARY

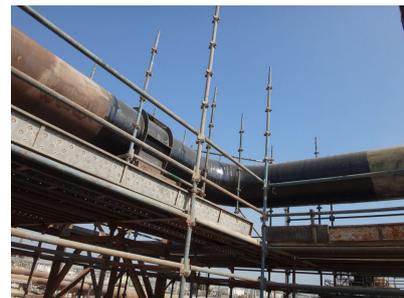
A team of 24 trained and certified installers worked from scaffolding erected around the elevated line to execute the repair. (Photo courtesy of ClockSpring|NRI)

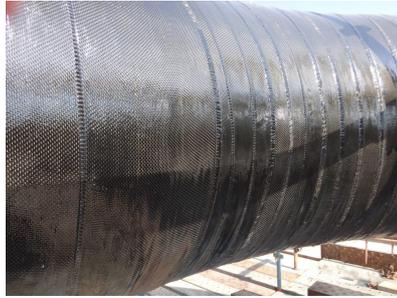
A closeup of the repaired line shows how the carbon fiber was wrapped around the line. The repair team covered the surface of the damaged area with two layers of carbon fiber affixed with HTA epoxy. (Photo courtesy of ClockSpring|NRI)

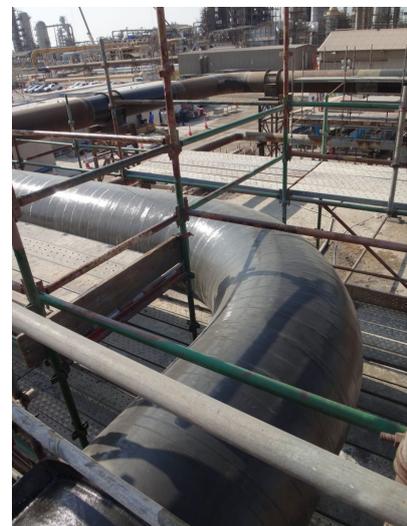
Despite being installed in a very hot environment where temperatures exceeded 45° C (113° F), the composite system cured perfectly, restoring the line to safe operations without introducing hot work and with no negative environmental consequences. (Photo courtesy of ClockSpring|NRI)
