Composite Solution Restores Pipeline Explosion Damage

PIPE DETAIL

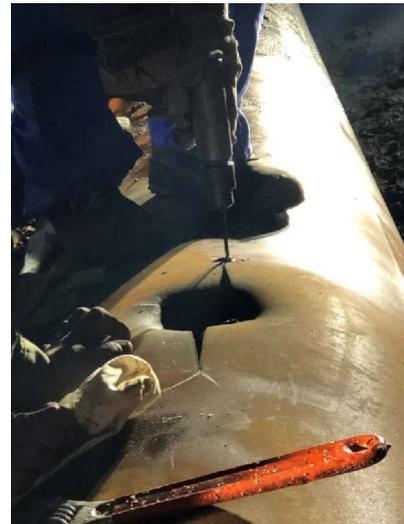
The explosion had created a 343 mm by 114 mm (13.5 by 4.5 inch) hole in a 711-mm (28-inch) carbon steel pipeline that was transporting crude oil under 10 bar (145 psi) pressure, and the wall of the pipe was bent inward in an irregular shape. This pipe was crucial to operations because it was the only pipeline delivering crude to the refinery. Without this line, the refinery would have had to completely stop production.

The installation team prepares to plug the hole in the pipeline. (Photo courtesy of ClockSpring|NRI)

As soon as the composite system was designed, MCSC WLL dispatched a team of 12 trained technicians to the refinery. Crude flow through the line was stopped while the team plugged the hole and began preparing the surface of the pipe for the composite repair, which was carried out with about 50% of the crude oil remaining in the line.

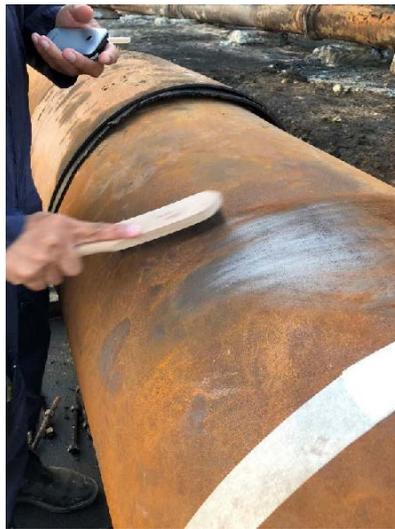
The installation team prepares to cover the damaged pipeline. (Photo courtesy of ClockSpring|NRI)

The repair designed for the pipeline was a DiamondWrap® system, which is made with a bidirectional weave of carbon fiber and a 100% solids epoxy that form a composite system that is stronger than steel. The structural system forms a pipe around a pipe, and each successive wrap increases the pressure rating. The bidirectional weave of the carbon fiber provides strength in both the hoop and axial directions, a design that practically eliminates creep, ensuring that there is no reduction in strength over time. This application was on a straight run of pipe, but because of its low profile, DiamondWrap® can be installed on tees and elbows and is ideal for

Technicians installed 26 layers of DiamondWrap® over a 3-meter (9.8-ft) length of pipe. Working continuously, the team was able to complete the repair in 16 hours, working through the night to finish the installation as quickly as possible to restore the line integrity so refinery operations could recommence.

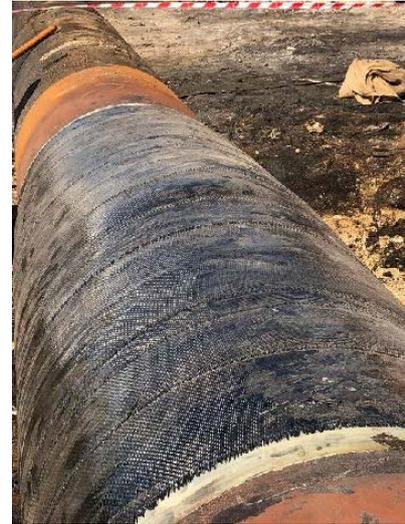
Pipeline integrity was restored within 30 hours, and refinery operations resumed less than 48 hours after the explosion. (Photo courtesy of ClockSpring|NRI)

Work was completed in less than 30 hours from the incident that caused the damage, and the pipe was back in service within 48 hours.
