Composites Enable Underwater Line Repair

PIPE DETAIL

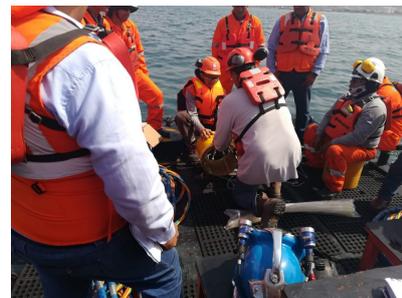
The installation team reviewed procedures before the dive. (Photo courtesy of Morken Peru SAC)

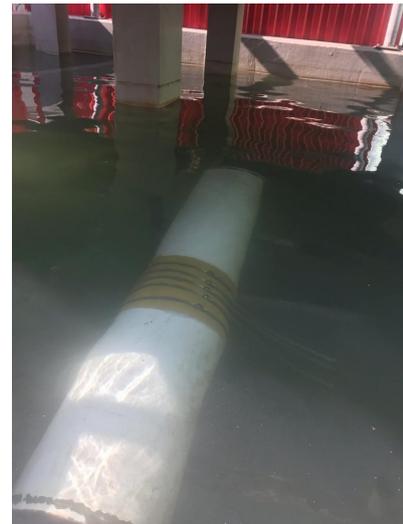
Working with trusted partners, the company repaired the damaged lines within a week, avoiding the cost of cutting and replacing sections of the pipeline and achieving a regional “first” underwater composite repair. (Photo courtesy of Morken Peru SAC)

A certified local diver entered the water with each prepared sleeve and placed it on the damaged pipe, installing a 4-layer Snap Wrap repair, adjusting the sleeves for optimal placement using metal hose

clamps and plastic zip ties. Following this approach, the team was able to complete each repair in approximately 2 hours, with a final cure delivered in 2.5 hours. The entire repair program was executed in just a few days.
