# Composite Contends with Arctic Conditions in Underwater Pipeline Repair

Corrosion on multiple girth weld joints on a 10-inch (254- mm) underwater gas pipeline  
2,785 psi (192 bar) design pressure  
1,035 psi (71.4 bar) MAOP  
Installed in 43°F (6°C) water

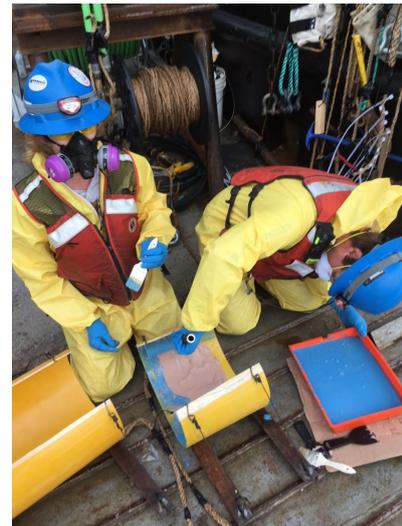
Team members on the barge apply filler and adhesive to the Snap Wrap repair sleeves in preparation for underwater installation.

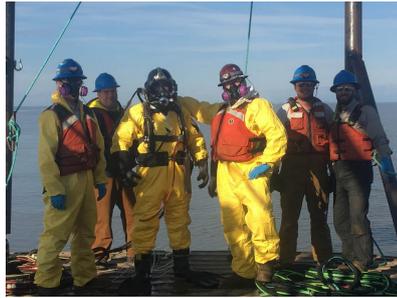
The diver prepares to begin the day's dives to install Snap Wrap repair sleeves on a 10-inch (254- mm) underwater gas pipeline.
