# Thermo-Wrap™ Inspectable Restores FPSO to Safe Operations

## PIPE DETAIL

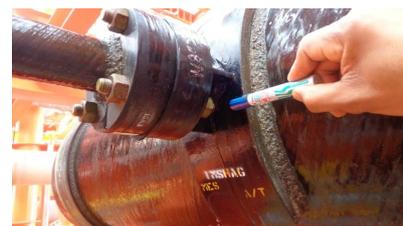
When an operator discovered leaks on several live glass reinforced epoxy (GRE) cooling water lines on an FPSO offshore Angola, immediate steps were taken to mitigate the damage. Stress and internal erosion had led to cracks and through wall defects in several places, including a joint. A repair solution was needed that would arrest the leaks and restore the line integrity for continued safe service.

A leak is detected on a joint between a 508-mm (20-inch) and 51-mm (2-inch) GRE branch line.
