Composite Repairs Live Butane Line

28-inch (711-mm) Carbon Steel line carrying Butane

Design Pressure 12.26 barg (178 psi)

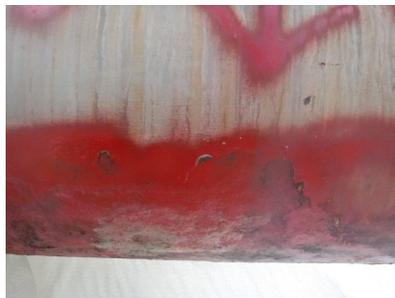
ClockSpring|NRI Europe Ltd. had a team of technicians already working on site at a refinery when a routine inspection revealed external atmospheric corrosion on a 711-mm (28-inch) carbon steel line carrying butane. A length of 1.6 m (5 ft) of line was severely corroded, resulting in extensive wall thinning. The line was designed for 12.26 bar (178 psi) pressure and 145°C (293°F) and was operating at 81°C (178°F).

A routine inspection revealed external atmospheric corrosion on a 711-mm (28-inch) carbon steel line carrying butane.
