COMPOSITE contends with Arctic underwater pipeline repair

Composite technology is proving to be valuable in repairing critical infrastructure in exacting environments. By **Buddy Powers and Martin Pashuck, ClockSpring|NRI**

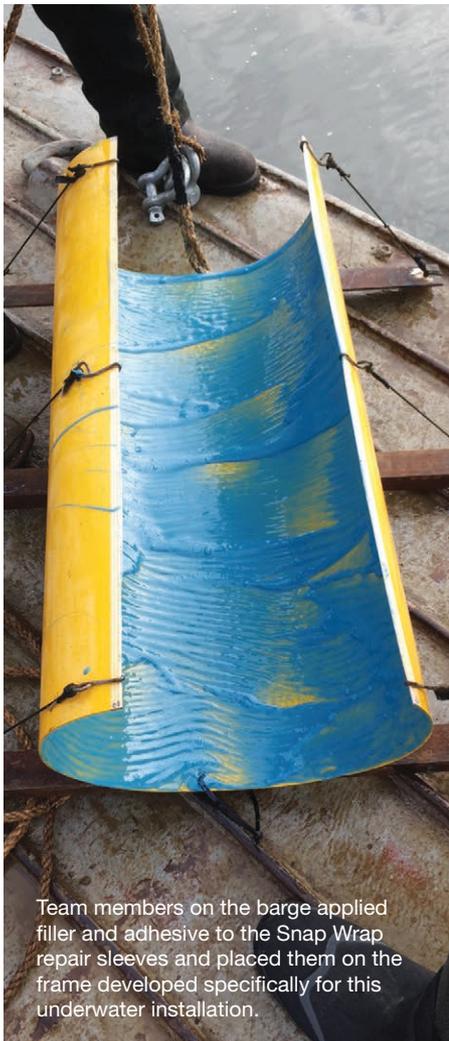
Team members on the barge applied filler and adhesive to the Snap Wrap repair sleeves and placed them on the frame developed specifically for this underwater installation.

Creative thinking led to a solution. The diver descended to the pipeline, located the girth weld, and loosely installed band clamps before and after the repair area so it would be easy to find the correct landing spot for the composite sleeve. Meanwhile, the team created a frame that could hold the prepared

split sleeve in the open position during the dive to make placing it on the pipeline much easier. Using the frame and ties cut the application time in half, which made the installation process much more efficient.

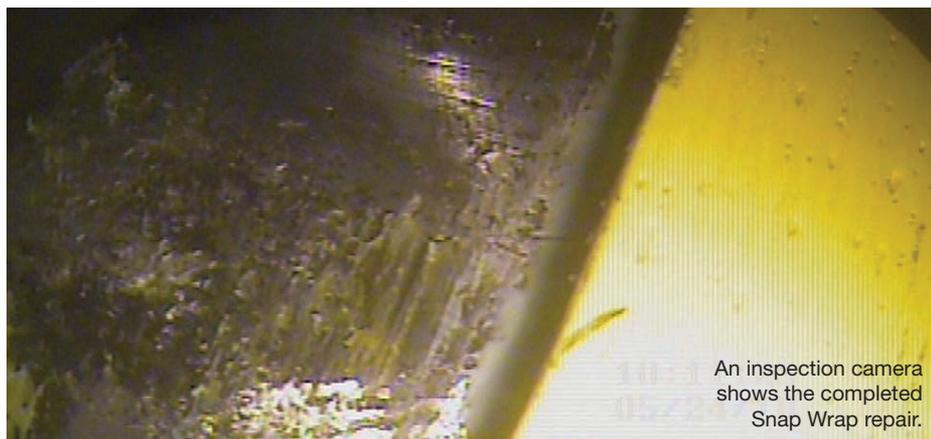
An inspection camera shows the completed Snap Wrap repair.

Following this work programme, the diver repaired all the damaged girth welds and restored the line to safe working order.
