RenewWrap®

Carbon Fiber Strengthening System

Application: Column and Cap Repair

Client: South Carolina Department of Transportation (SCDOT)

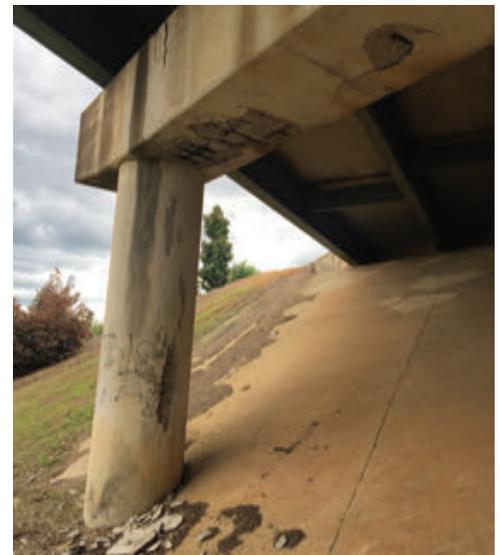
The SCDOT found corrosion-related deterioration of the pier caps and columns supporting the Butler Road bridge over I-385 in Greenville, SC, during a routine inspection. The corrosion was caught early enough and was limited to only one column and a couple of locations on the pier cap to be repaired by the SCDOT maintenance crews. To prevent further deterioration, the SCDOT determined it was necessary to repair the damage, restore any loss of strength and protect the pier from further deterioration. A repair that could be made quickly and with as little disruption to the traveling public was important.

Column and pier cap prior to repair.

ClockSpring|NRI engineers visited the job site with the SCDOT to assess the scope of the problem and understand the objectives of the SCDOT. After the site visit, ClockSpring|NRI recommended using GeoStrong™ geopolymer repair mortar to make the vertical and overhead spall repairs on the pier cap, followed by the application of a single layer of RenewWrap FRP strengthening system to restore any loss strength and to protect the pier cap from further deterioration.

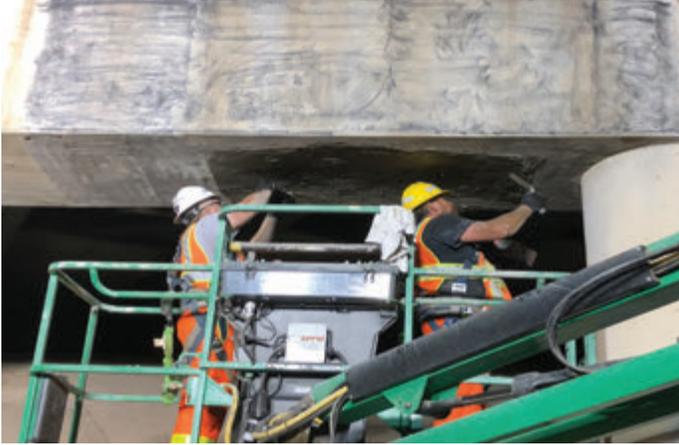
Application of GeoStrong repair mortar.

The work was completed by the SCDOT maintenance crews in the evenings to minimize lane closures on I-385. Standard concrete repair methods were used by the SCDOT to make the repairs. Once the loose concrete was removed and the corroded rebar was cleaned, the GeoStrong geopolymer repair mortar was placed by hand to fill the spalled sections. Unfortunately, heavy rains in South Carolina forced the crew to shut down before the patching could be completed. When they returned two weeks later, they could patch directly over the cured GeoStrong material with confidence knowing that cold joints are not a concern with ClockSpring|NRI innovative geopolymer material.

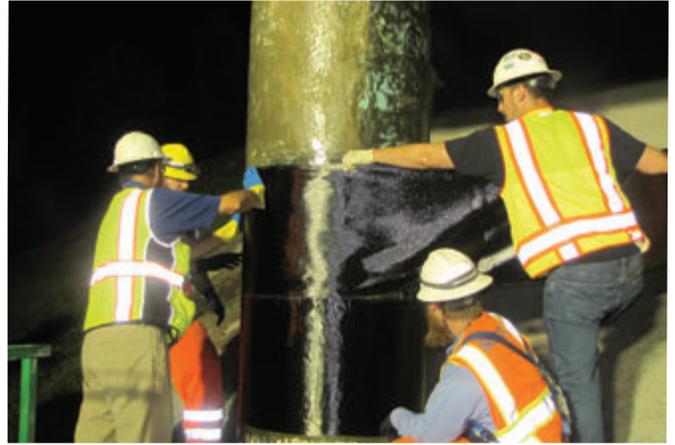
SCDOT maintenance crew wrapping pier cap with RenewWrap FRP system.

When the GeoStrong mortar was applied and cured, engineers instructed the maintenance crew on how to apply RenewWrap FRP system to the pier cap and column. The carbon fibers were aligned in the same direction as the corroded reinforcing steel to provide additional strength and protection to the damaged areas. The following night, the SCDOT coated the RenewWrap with a Sherwin-Williams epoxy paint to match the rest of the pier. To the traveling public, the pier looks like a brand-new structure.

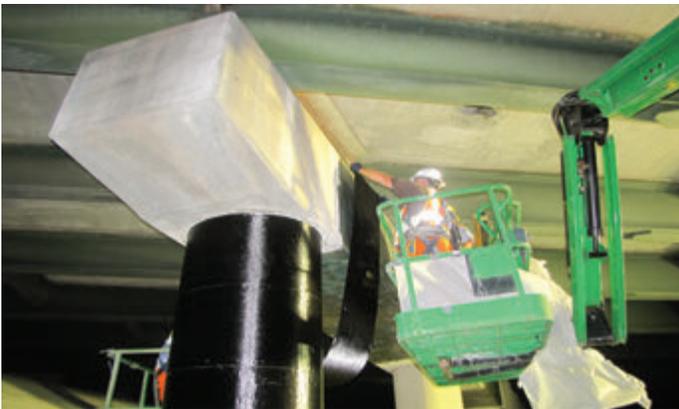
Application of RenewWrap FRP around column for confinement.

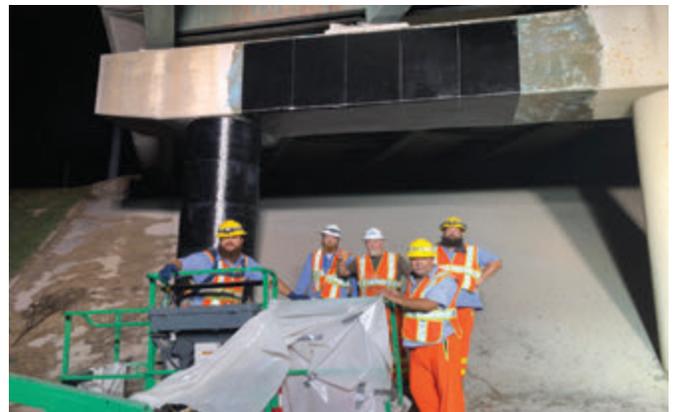
Completed repairs prior to coating.

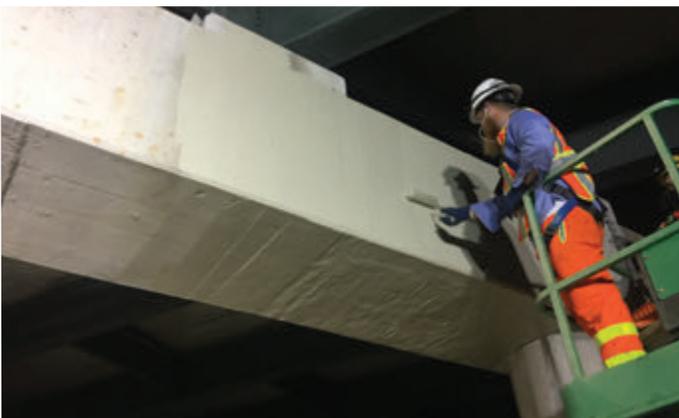
Painting RenewWrap FRP system with epoxy coating.

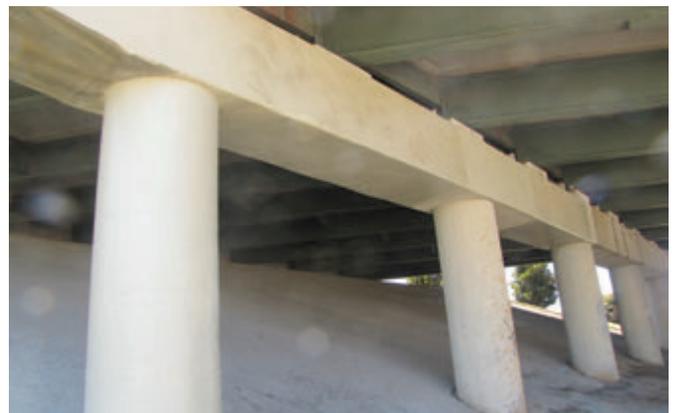
Completed column and pier cap.
