CLOCK SPRING®

Pipe Support

The Fast, Economical Solution for Low Pressure Pipeline Repair

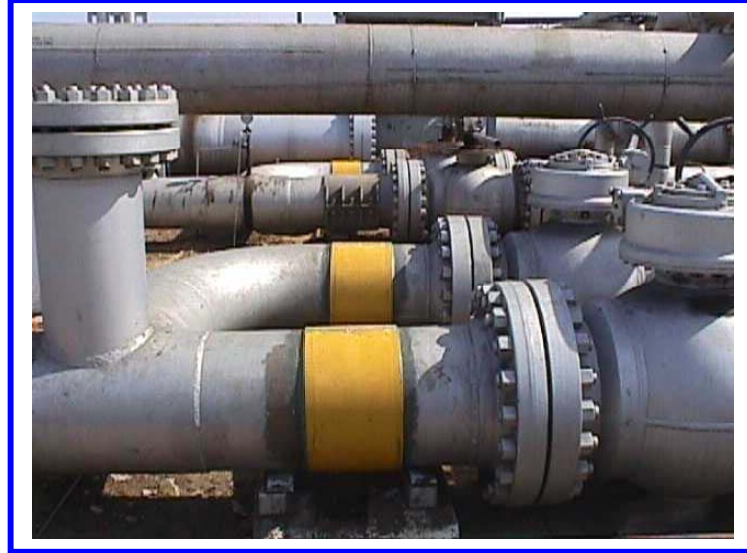
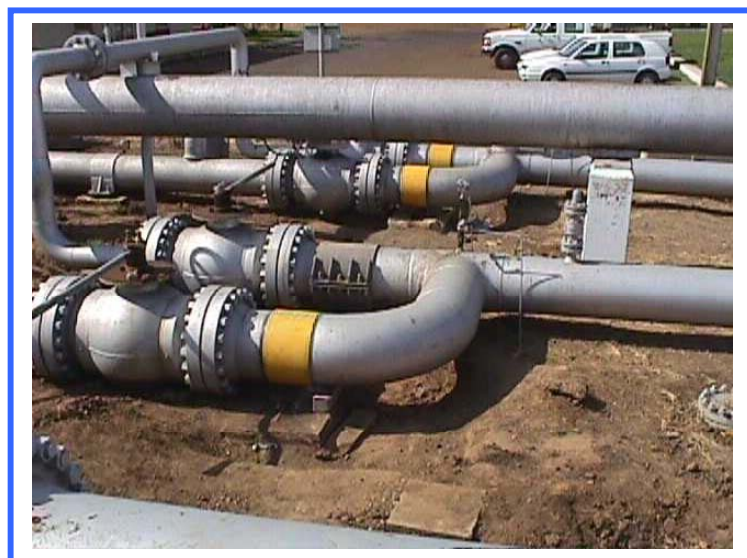
3 x 18" repairs were made in support locations.

The Pipe could not be raised so blocks were inserted and the supports were cut away. The pipe was then hand prepared to remove all traces of zinc paint and any corrosion scabs.

The 3 repairs were completed within 2 hours.
