Contour Strengthens Welded Joints for HDD

Welding joints on a 1,000-mm (39.3-inch) carbon steel natural gas line needed reinforcement

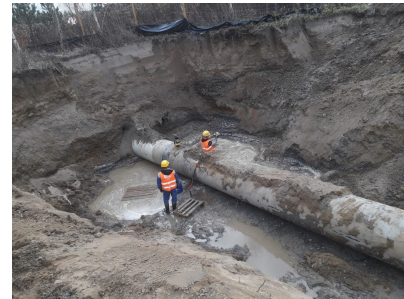
Clock Spring trained and certified installers assess the 1,000-mm (39.3-inch) carbon steel natural gas line.

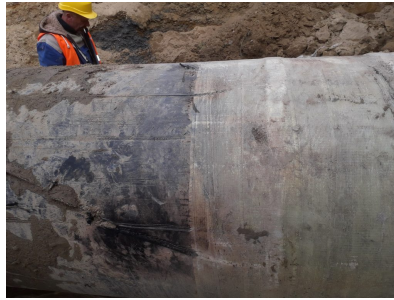
The two-layer Contour system, installed along a 700 mm (27.6 inch) section of pipeline, acts as mechanical protection over welded joints.
