AVT EZ Valve™ Restores Water Treatment Plant Main

8-inch (200-mm) AVT EZ Valve™ installation on cast iron pipe

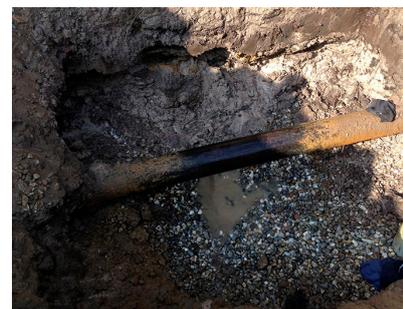
Excess Water is drained, pipe is thoroughly cleaned and prepped for valve body.

Working with local distributor Gutermann SARL, AVT began the installation. The first step was to thoroughly clean the pipe and prepare it for the installation of the valve. Next, the valve body was secured to the pipe, and the cutting tool was attached and leveled in preparation to cut the damaged portion of pipe. With the valve body properly place, installers cut a 120-degree slot cut across the top of the pipe. When the

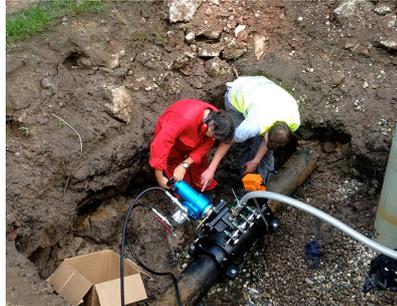
Cutting tool is leveled and prepped for milling.

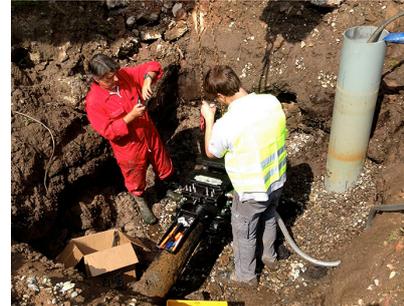
Wedge gate is lowered and drip tight seal is created.

cutting was completed, the team closed the temporary knife gate and lowered the bonnet into place and secured it to the valve body. At this point, the wedge gate was lowered to create a drip-tight seal.
