PVC Line Returns to Service Thanks to AVT EZ Valve™ and R2M Site Services

PIPE DETAIL

4-inch (100-mm) PVC
 Clean Water Main

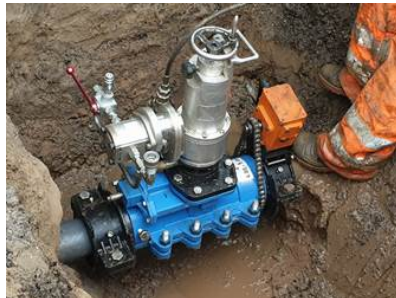
Three technicians installed the 4-inch (100mm) AVT EZ Valve™ on a PVC clean water main in 3 hours, delivering a durable solution without interrupting service. (Photo courtesy of R2M Ltd.)

A trained 3-man installation team from R2M Site Services excavated the area and installed the AVT EZ Valve™ in only 3 hours, providing a durable and cost-effective solution that will allow improved access and control on the repaired line. An alternative repair would have required more extensive excavation, more components, and more time to achieve the same results and would have disrupted service while the repair was being executed.

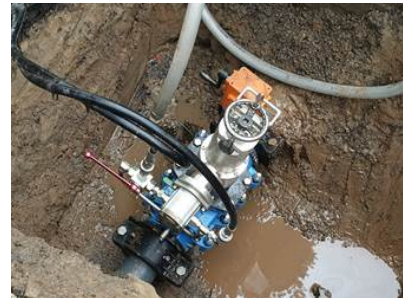
Using the newly installed left close, 4-inch (100-mm) AVT EZ Valve™ will make future maintenance less intrusive, less complicated, and less expensive. (Photo courtesy of R2M Ltd.)

Once installed the AVT EZ Valve™ becomes a tangible and useful asset for utility companies. It is registered on their GIS system with a permanent record of its exact location should the company need to shut off water in that area in the future. The valve works and is operated as a standard valve and is understood by water utility workers across the industry.

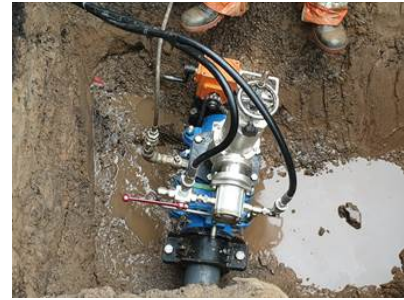
(Photo courtesy of R2M Ltd.)

team determined that the best solution would be to install a 4-inch (100-mm) AVT EZ Valve™ that would be operated with a left hand close. Because of the unique inline valve design that allows water to continue flowing through the pipe while the repair is being made, there was no need to shut off water while the installation team from R2M Site Services got to work.

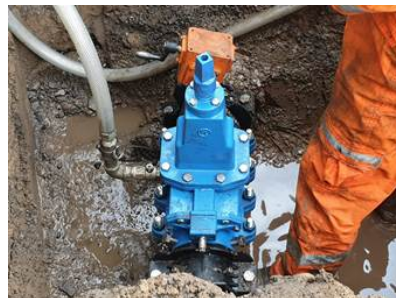
(Photo courtesy of R2M Ltd.)
