The following report is a pictorial and text account of procedures and operational techniques employed for a Storage Terminal, 42" Suction Line Repair utilising the Clock Spring repair system.

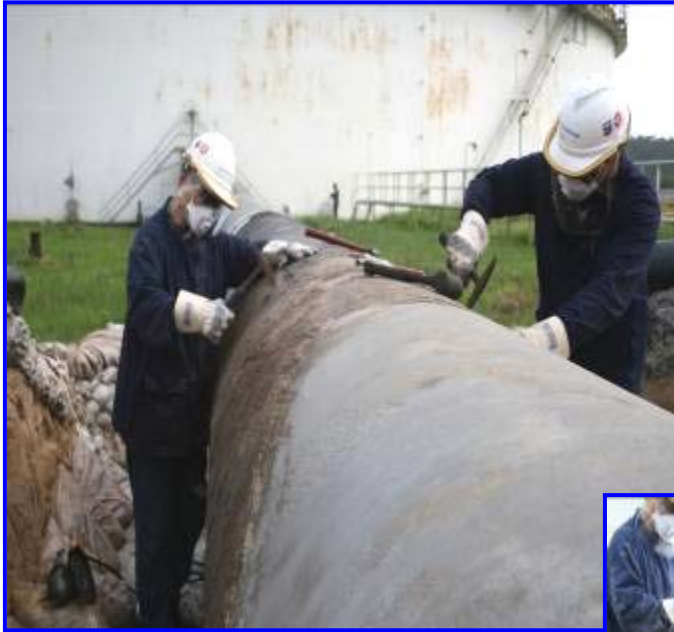
In order to have an accurate preliminary NDT inspection all coating and corrosion scale was removed manually using hand tools. This avoided any further damage to the pipe until an accurate measurement of the remaining wall thicknesses could be ascertained.

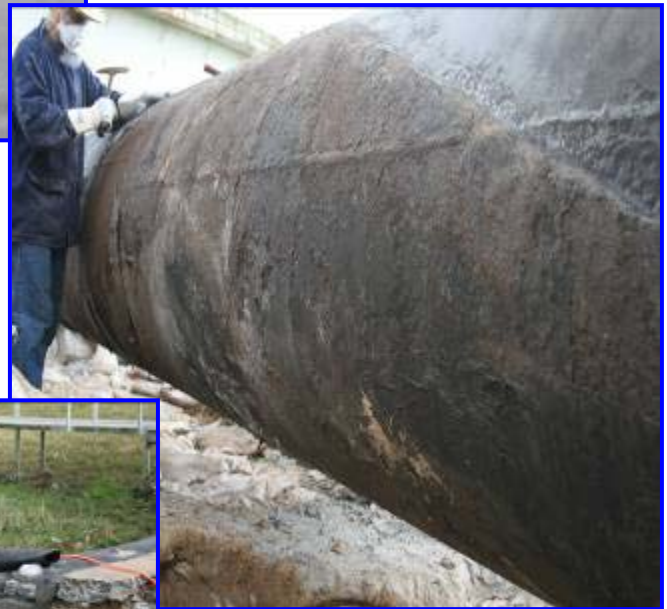
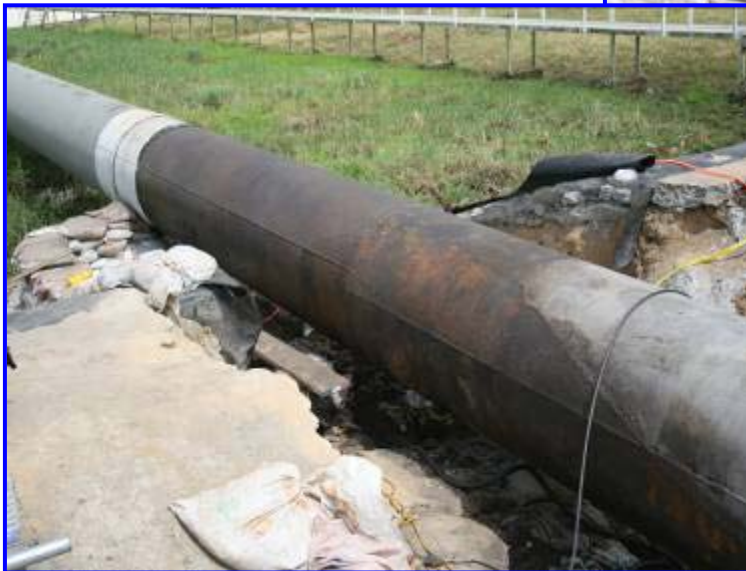
Having carefully and gradually removed the scale and coating the underlying steel was exposed thus enabling the NDT inspection to take place.

With the preliminary areas of the pipe surface cleaned it was possible to NDT the worst areas of the pipe and to obtain clearance for power tools to be used to prepare the remaining pipe for the Clock Spring repair application.

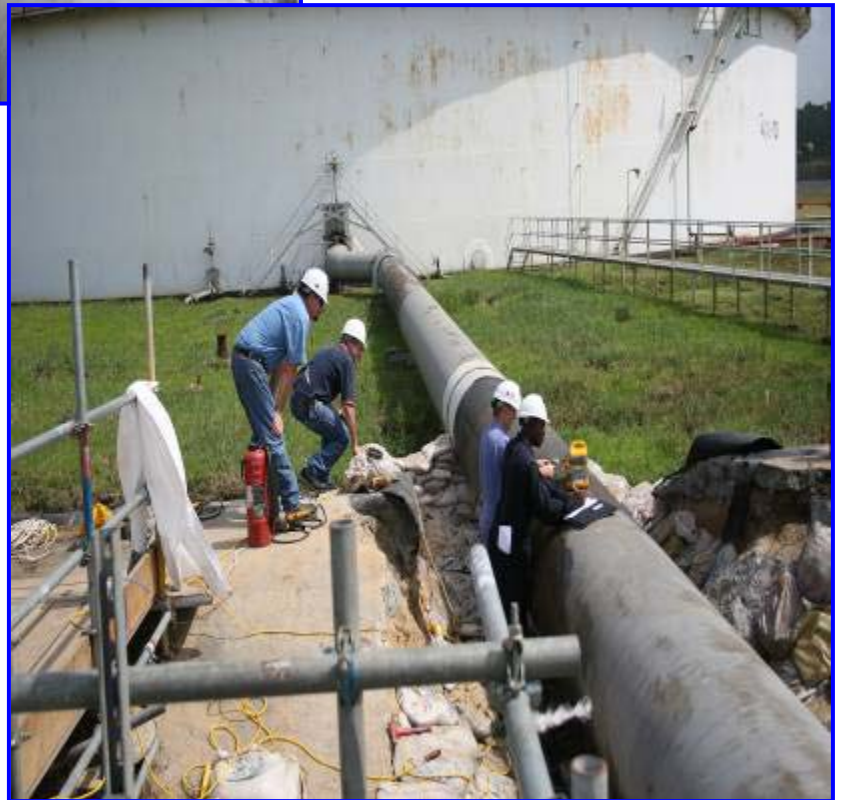
With the NDT inspection completed and all parties concerned were satisfied the use of mechanical devices would cause no further penetration/perforation of the remaining wall thickness the work to prepare the complete pipe section for the Clock Spring repair installation could commence.

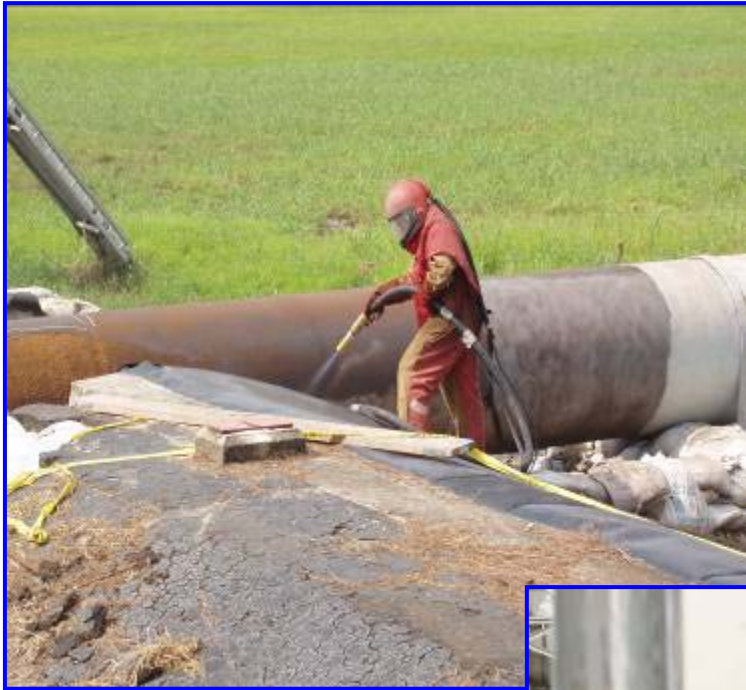
Blasting crew in operation. This operation was by far the most expedient.

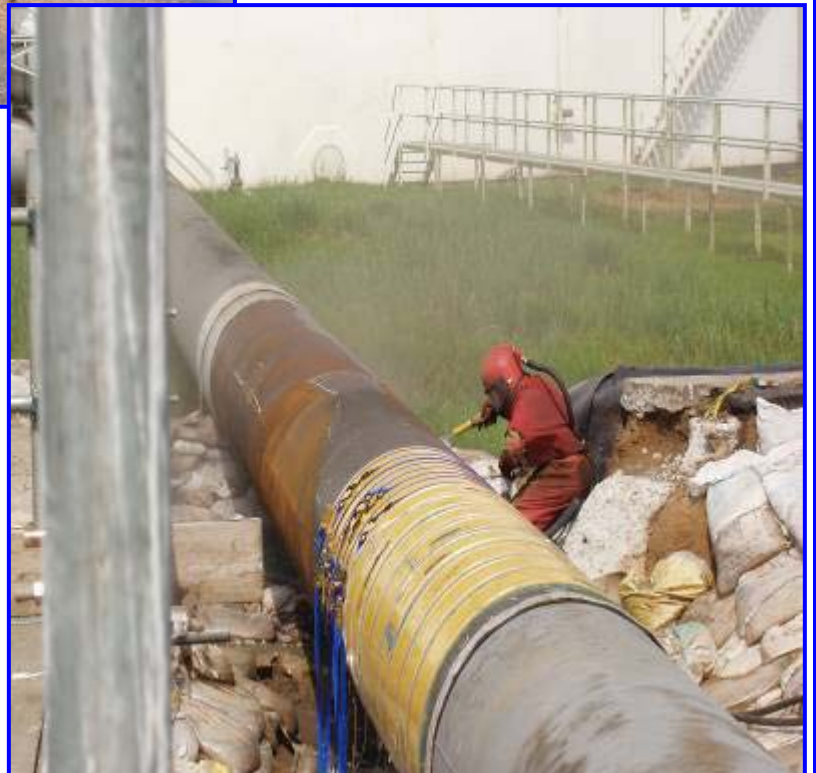
Here again the blasting crew on the pipe, notice the 8 Clock Spring wraps and 4 moulds already installed.

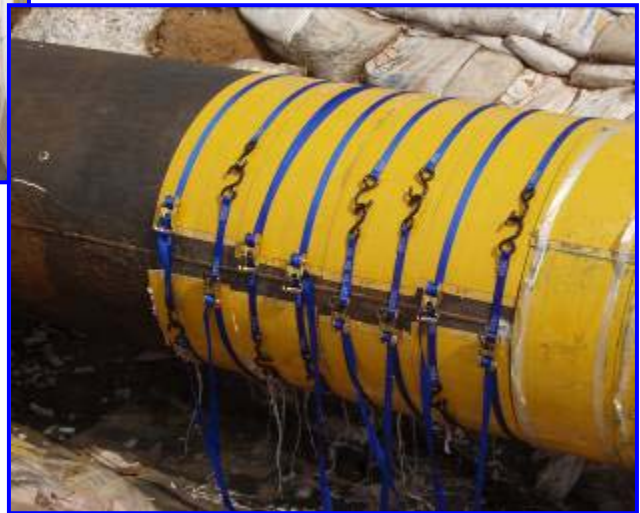
**Stage 2:** The filler is held within a 42" mold and secured with tensioning straps. This ensures the filler is equally distributed around the pipe and "fills" the corrosion pits.

As is visible here all surplus filler is extruded from the mold leaving a uniform surface for the Clock Spring installation.

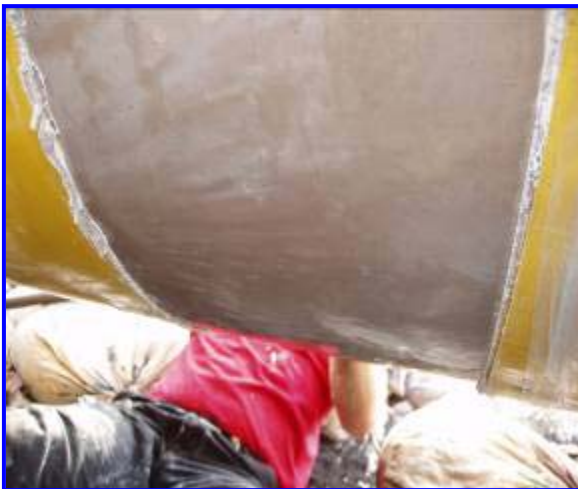
**Stage 3:** After the filler compound has cured (30 minutes) the tensioning straps and mold can be removed.

The area is now ready for the Clock Spring coil to be installed.

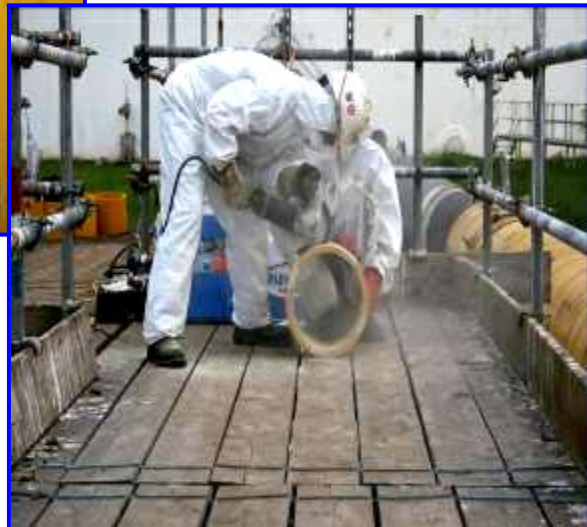
The cut for the coil to bridge the weld is made onsite using a Diamond cutting disc.

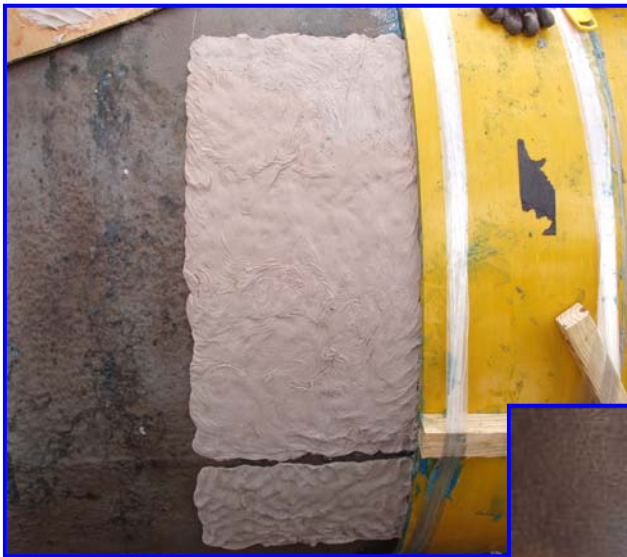
These photographs show the application of more areas of filler both for the corrosion and around the pipes longitudinal weld seam.

This procedure is carried out on all longitudinal and spiral weld seams to avoid any gap and tenting underneath the coil when it is tightened over the weld seam.

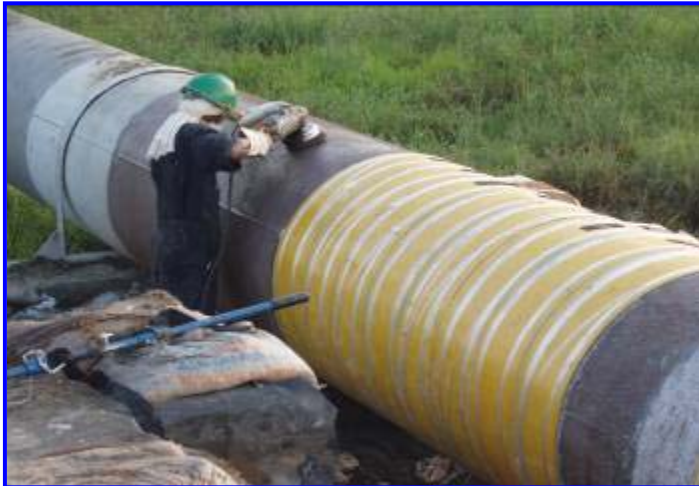
Prior to the Clock Spring installation the surface of the pipe was finally cleaned with a solvent wipe. This process removes any grease or other forms of contamination which may have occurred during the blasting process.

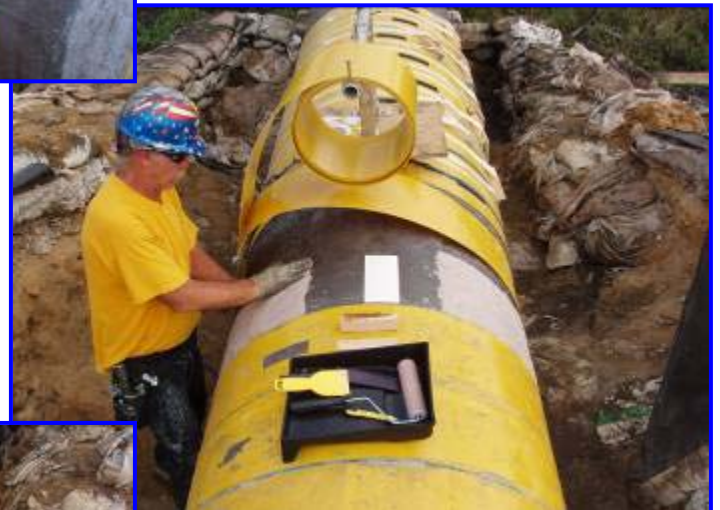
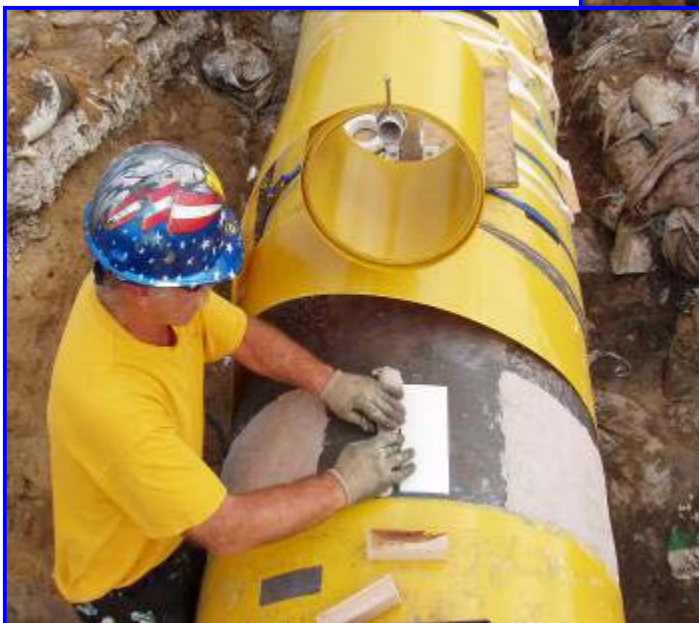
After application of the filler the Clock Spring starter pad is applied. Due to the pipe diameter and clearance around and underneath the pipe the spool feeder installation method was used in this instance.

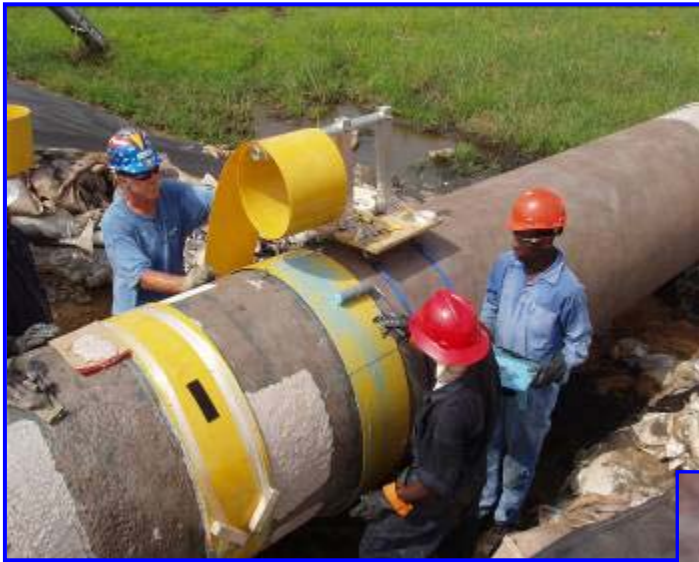
Installation of Clock Spring using the spool feed method.

Once the coil has been wound around the pipe and adhesive applied to the complete surface area of the coil, the sleeve is then slid and placed over the filler and onto the starter pad.

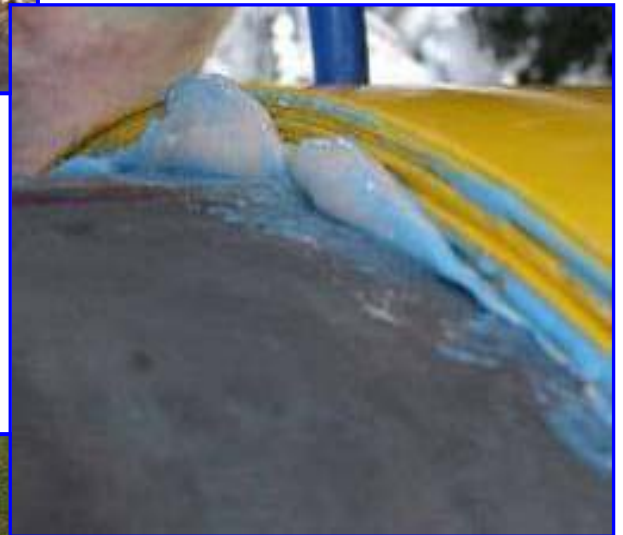
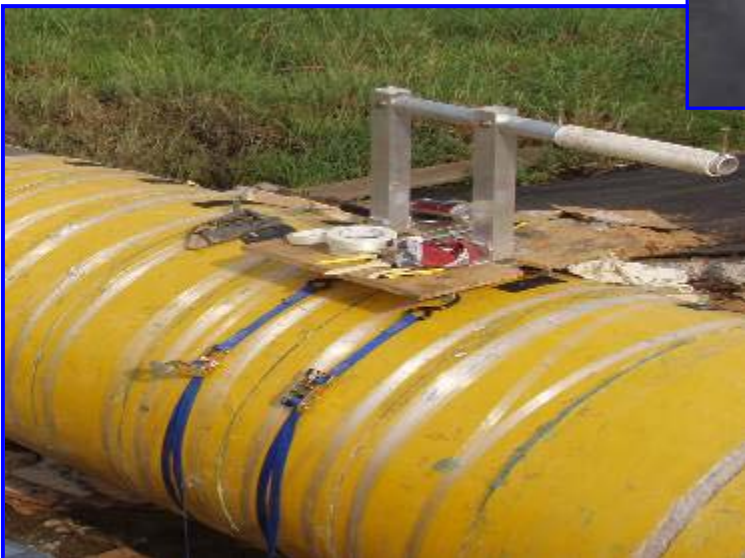
The coil is then tightened using the cinch bar to extrude all excess filler and adhesive and to ensure all voids are completely filled.

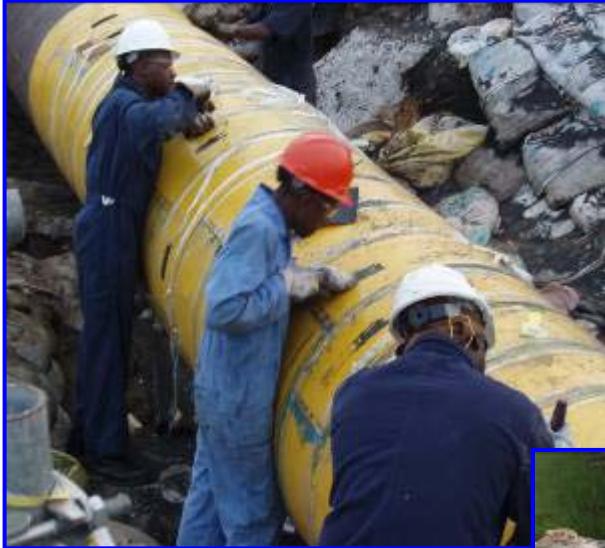
The coil is then held in place with filament tape and allowed to cure (up to 2 hours). During this time all excess filler and adhesive is removed.

Coils are installed side by side to accommodate the complete repair length and external extent of the corrosion.

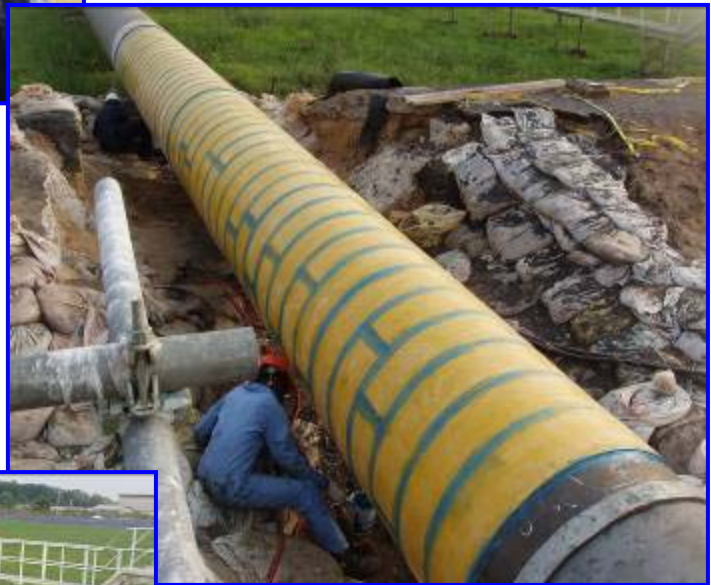
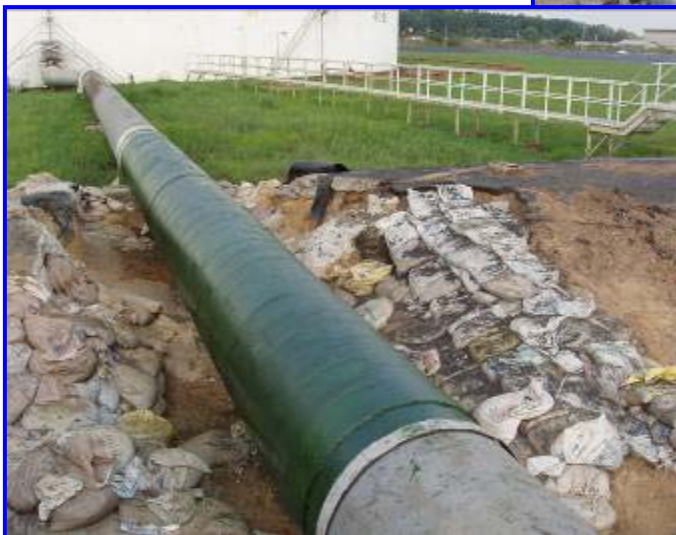
The final part of the installation procedure is to apply a suitable corrosion coating over the complete length of the reinforcement.
