CLOCK SPRING®

Application Note Clock Spring® Marker

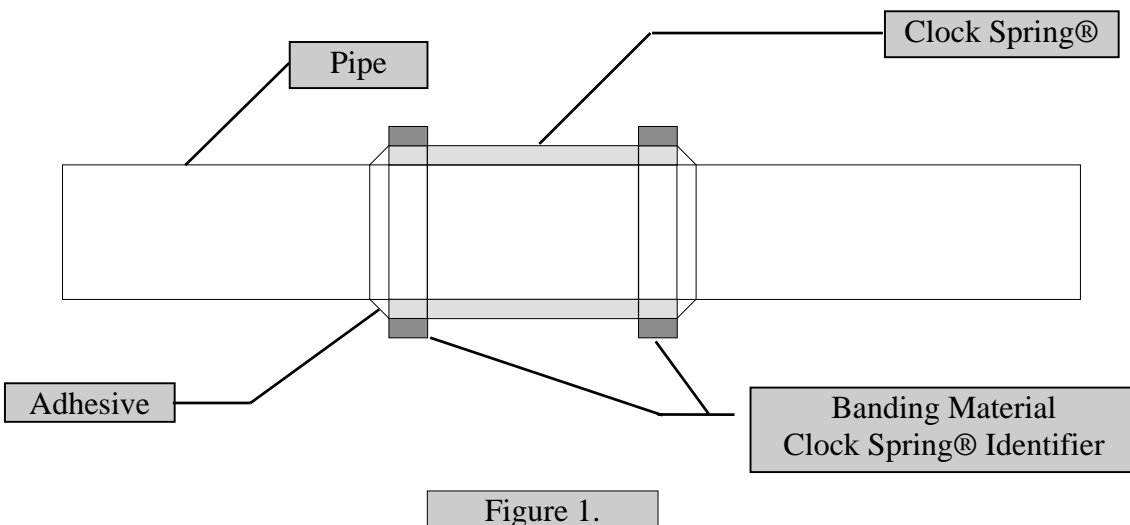
Inspection data showing Clock Springs identified by banding material.

Figure 1 shows metal banding placed on top of the Clock Spring®. While this ensures that the banding is insulated from the pipe, it does require additional material. Alternatively, the metal banding can be placed on the pipe immediately outside the Clock Spring®. In this case, three (3) wraps of banding can be used. The banding in this case should be insulated from the pipe by a thin membrane. Banding in this position will be easier for the inspection tools to detect and is most likely to generate an easily recognizable signal in the data.
