# CLOCK SPRING®

## BURST TEST RESULTS

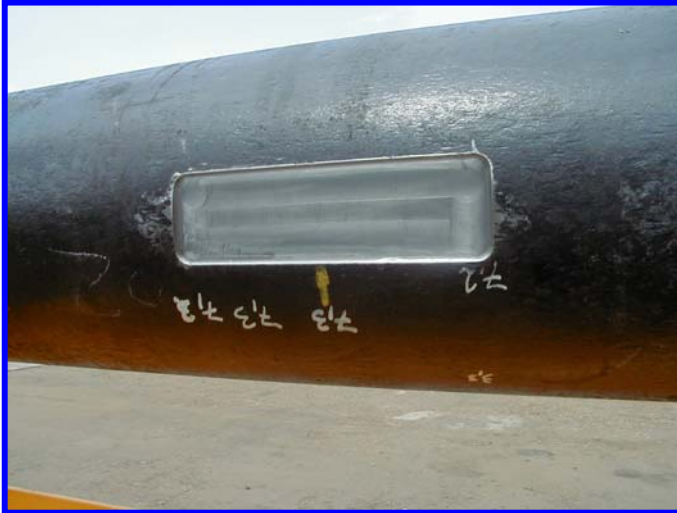
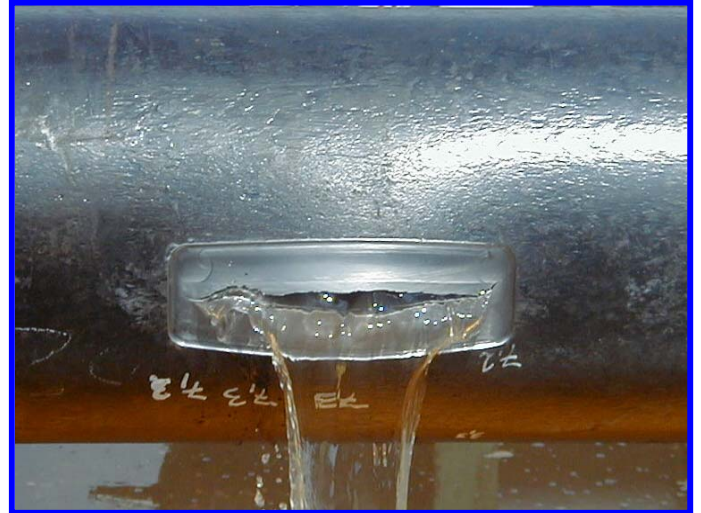
### BURST TEST ON UNREPAIRED SPOOL

Defect Length = 7 in, Defect Width = 3 in, Depth = 80% Wall Loss

**Defect Burst at 1015 psi**

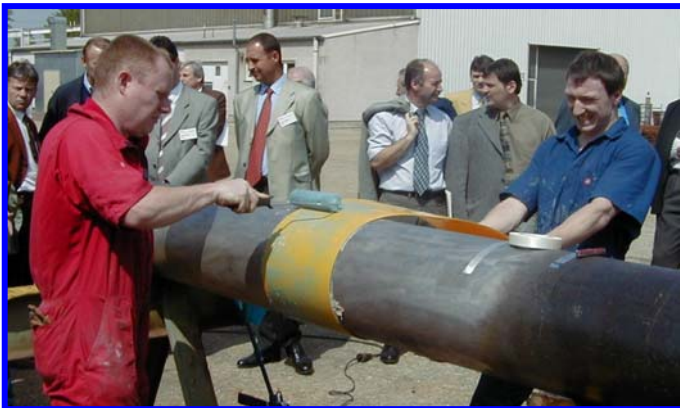
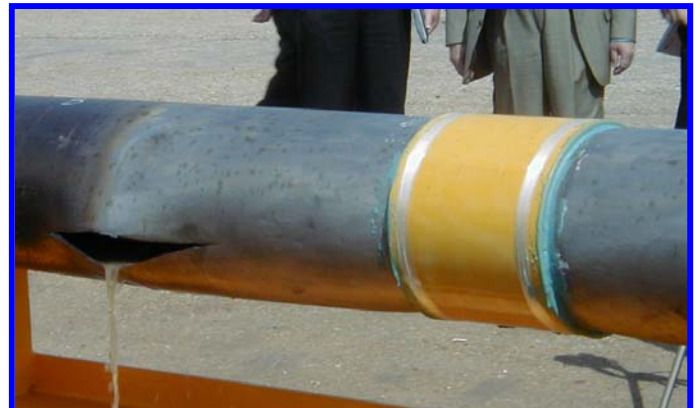
### BURST TEST WITH CLOCK SPRING REPAIR

Clock Spring Repair Made on Same Size Defect

**The Pipe Burst at 2900 psi!**
