**Test Certificate**

Item: 1 pipe section (18" long x 3.5" diameter) coated with fiberglass composite submitted to complete Cathodic Disbondment testing procedures.

Specification ASTM G 8-96(2003) Modified per customer requirements.

Cathodic Disbondment – ASTM G 8-96(2003) Test Results

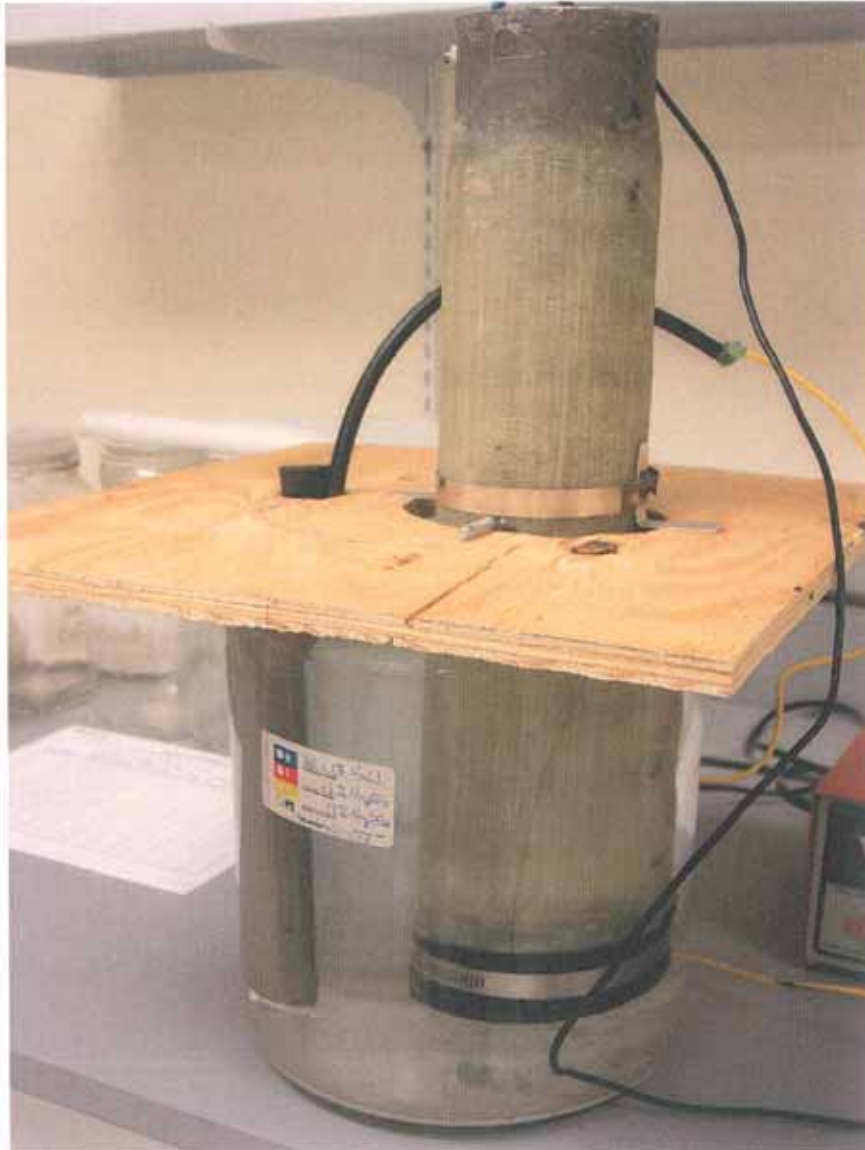
Photo 1. Sample appearance at beginning of test.

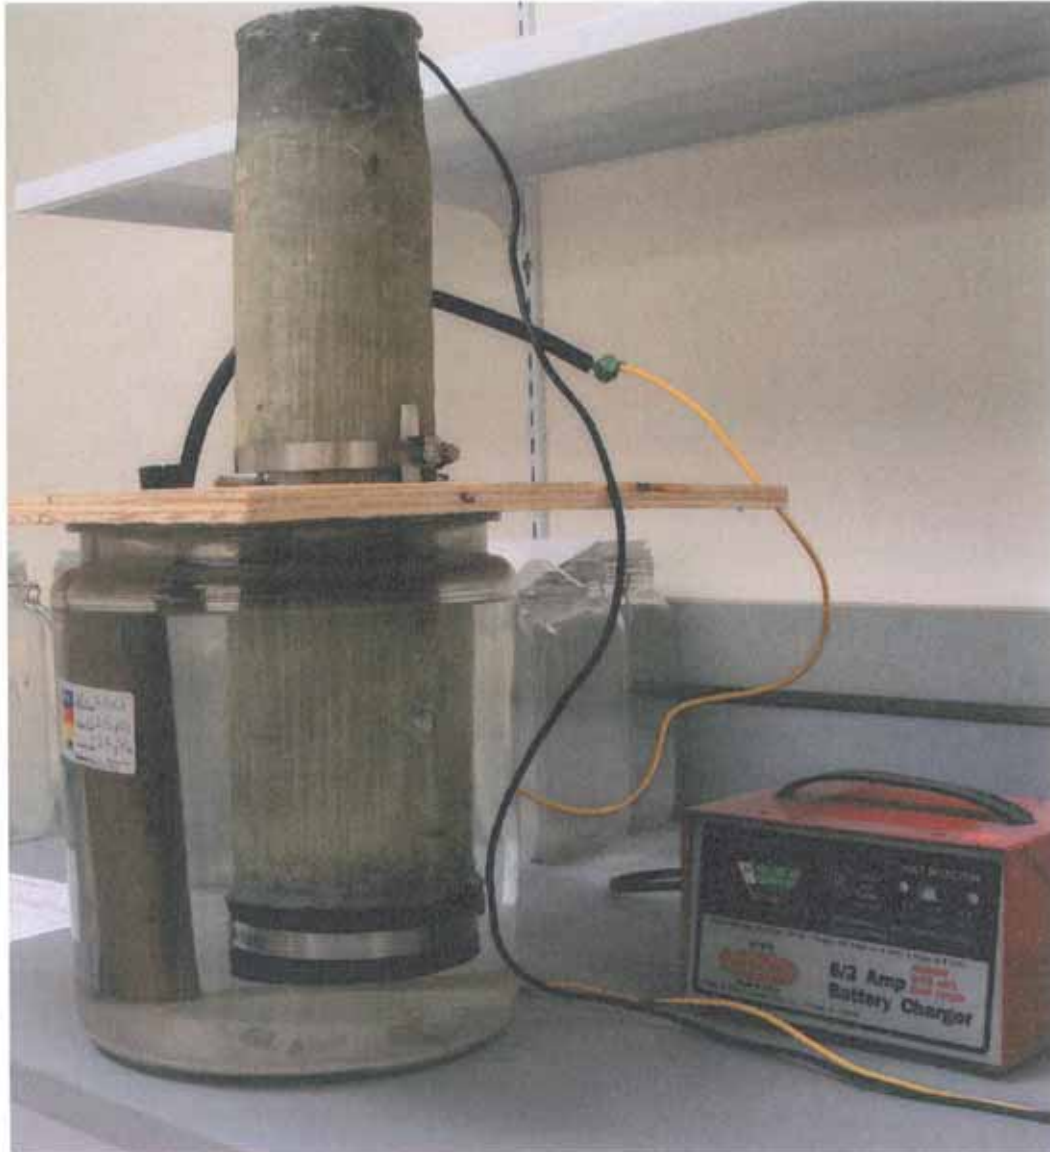
Photo 2. Sample appearance at middle of test.

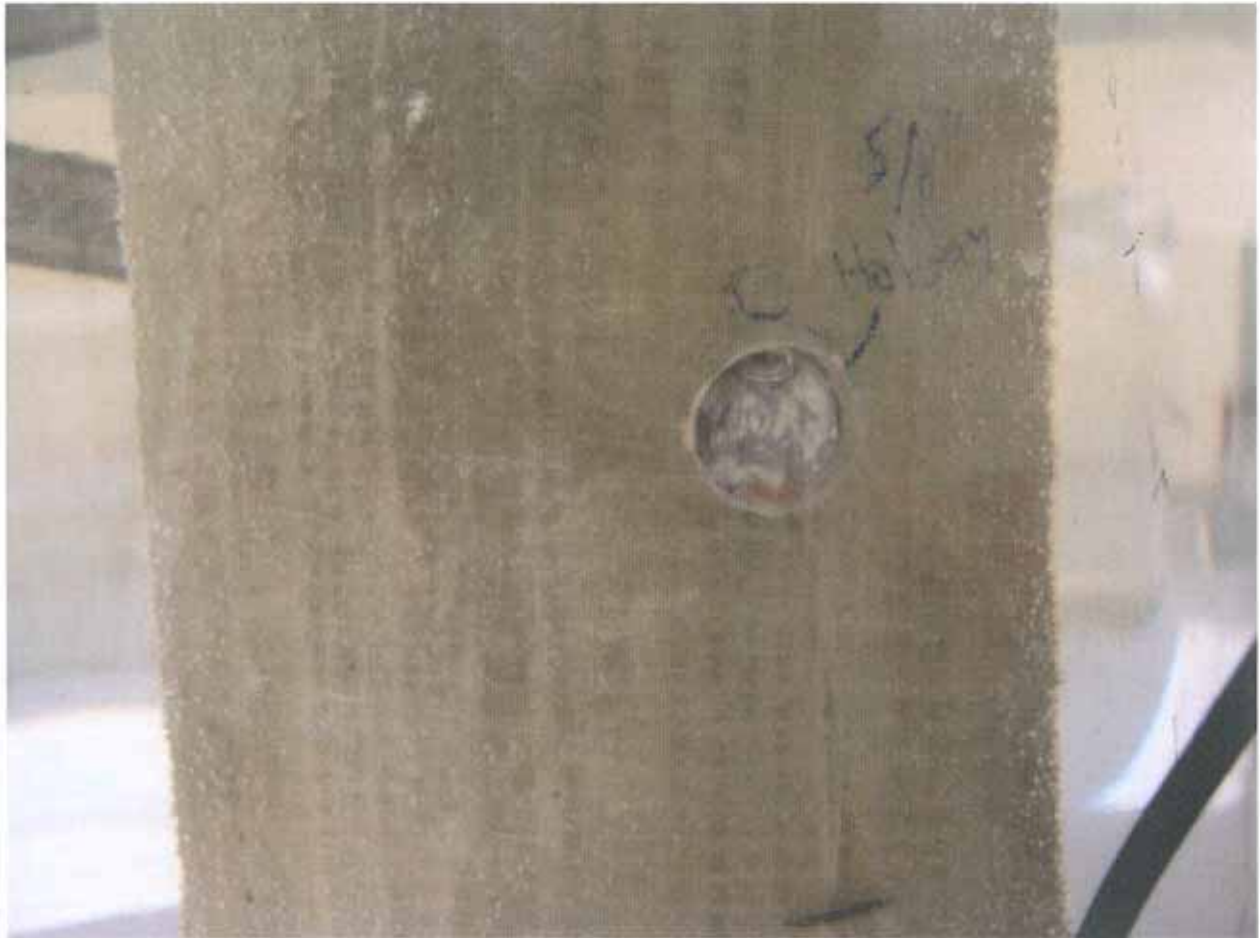
Photo 1. Appearance of holiday at middle of test. Note the buildup of a white deposit in the holiday and the bubbles forming on the coating surface in addition to in the holiday.

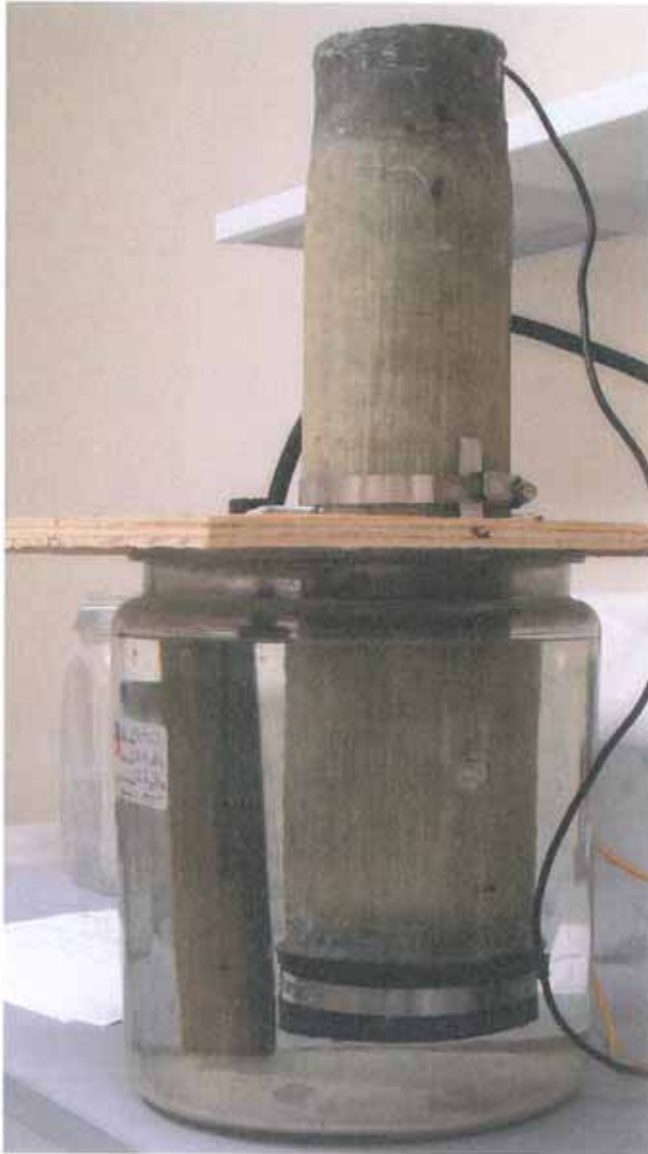
Photo 1. Sample appearance at end of test.

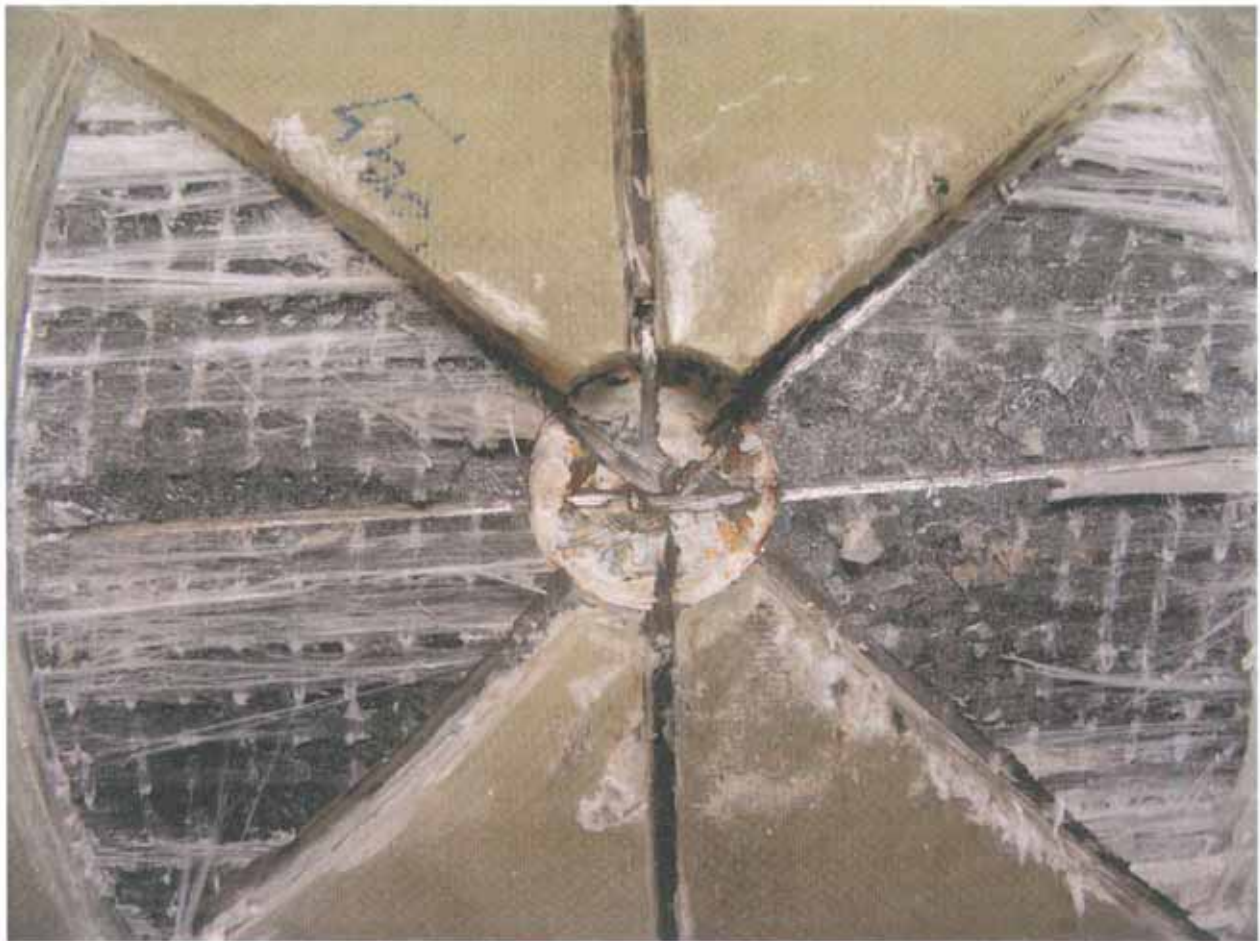
Photo 1. Sample holiday and disbonded radius appearance at end of test. Note there appears to be no disbondment due to the cathodic action.

Sample	Point 1	Point 2	Point 3	Point 4	Point 5	Point 6	Point 7	Point 8	Average
803065-1	0	0	0	0	0	0	0	0	0

*\*Note: There was essentially no detectable failure of adhesion in any direction from the holiday for this sample.*
